**Medieval Merchant's House,  
58 French Street, Southampton SO14 2AT**

**Graffiti Survey summary**

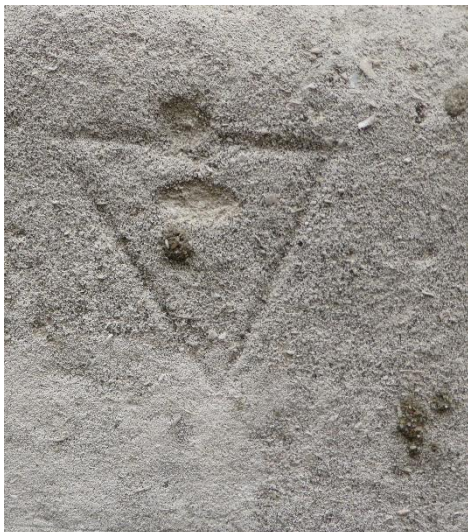
Some of these stone blocks have marks on them, including a triangular shape which, from its regularity and neatness, seems likely to be a mason's mark. (Fig 1)

*Fig 1 Exterior south wall. Mason's mark*

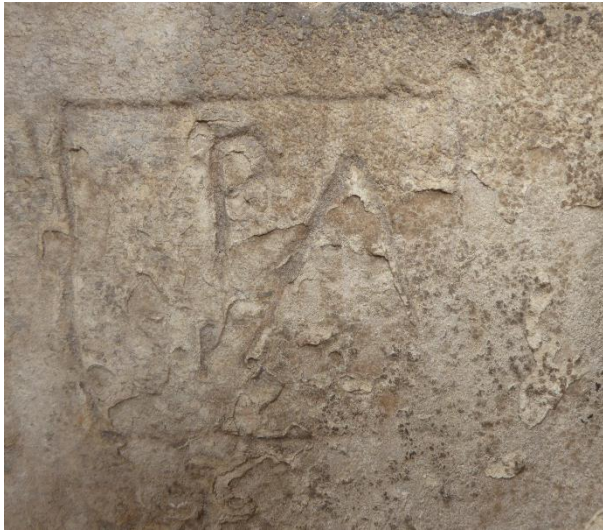
Fig 2 East wall, south side of doorway. Boxed initials PA

A fainter incised shape was found on a block on the west jamb of the south doorway. On the east side of the house, on the wall south of the east doorway, is some *in situ* graffiti. This consists of boxed initials PA (Fig 2). On the south side of the doorway arch is a much-weathered shape which could be the remains of the fleur-de-lys mentioned in

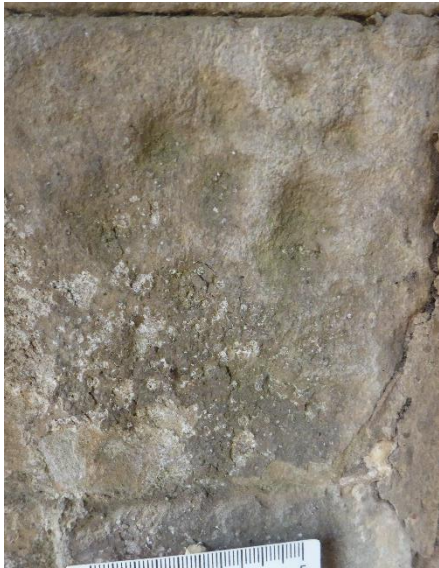
an earlier report as a *fleur de lys on ashlar within the entrance hall/passage*. (Fig 3)

Fig 3 East doorway, south side, possible fleur-de-lys

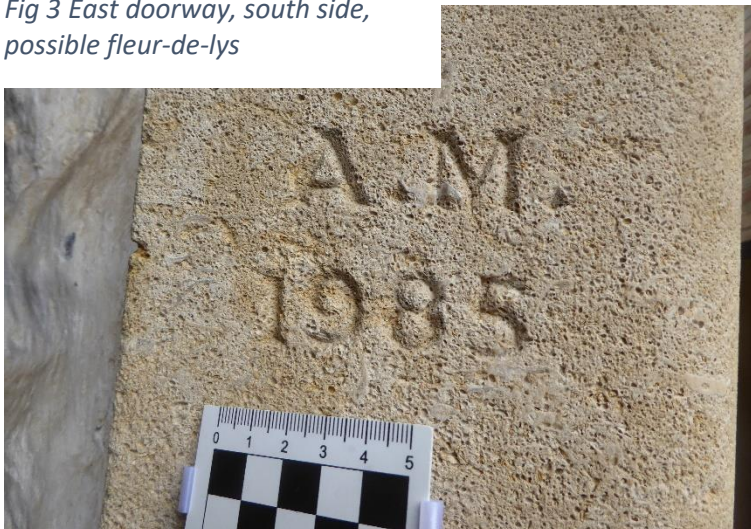
On the south side of the arch over the east door, and on the jamb of the south doorway are the neatly inscribed dated initials: A.M. 1985. (Fig 4) The Site Manager was informed by former Inspector of Ancient Monuments, Glyn Coppack, that these initials stood for Ancient Monuments, and related to work completed in that year.

Fig 4 South doorway, Ancient Monuments inscription. A.M.1985

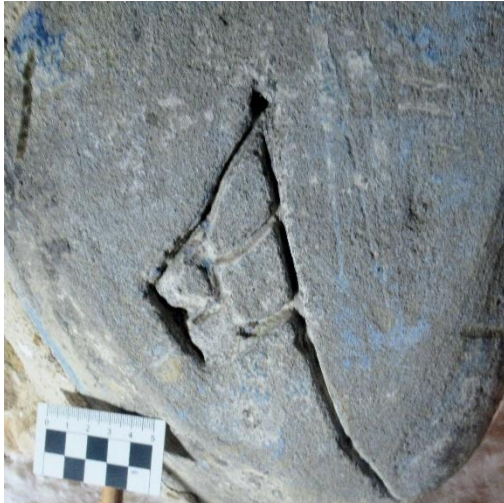
No graffiti was found in the central or hall room. Carvings on the north and south corbels in the most westerly inner room were recorded, although these were not considered to be true graffiti. The south corbel has carvings on two adjacent faces consisting of a flag shape, and an arrow with a horizontal line above it. (Figs 5, 6)

*Fig 5 Inner room, south corbel, flag shape*

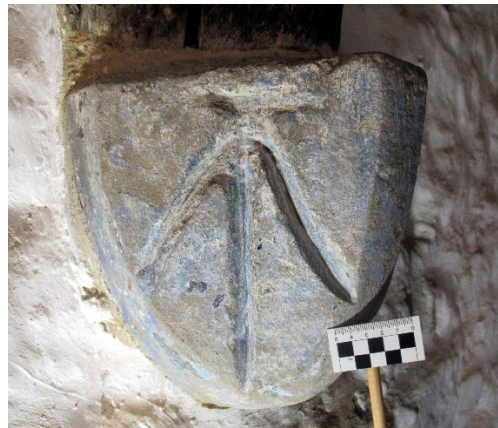
*Fig 6 Inner room, south corbel, arrow*

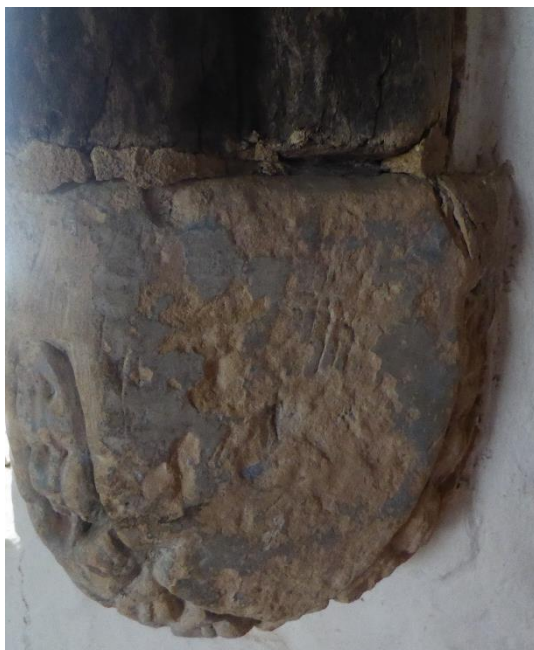
Traces of blue paint are also visible. An earlier English Heritage report recorded this as follows: *Merchant marks on the south corbel within the ground floor inner chamber*. The north corbel has indistinct faint scratches on both faces (Fig 7), with a decorative foliage motif on the underside and traces of earlier paint.

*Fig 7 Inner room, north corbel, scratches and paint*

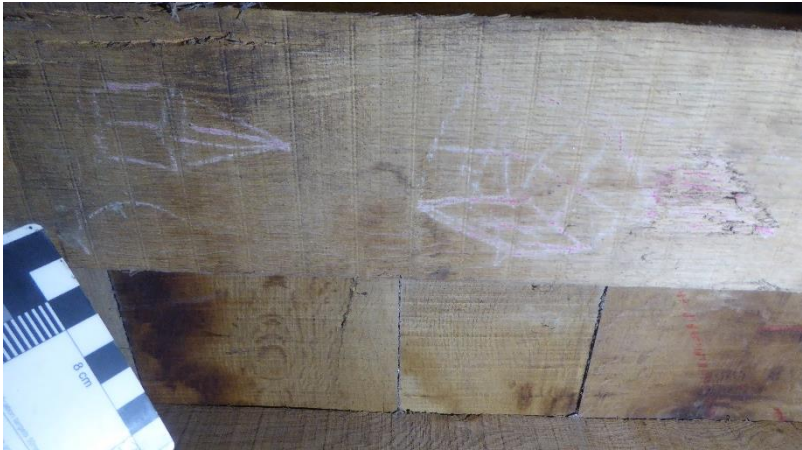
Some modern graffiti was found on the ceiling timbers of the passageway between the shop and hall. This comprises geometric shapes, possibly representing a building, drawn in red and white chalk. (Fig 8)

*Fig 8 Passageway ceiling, modern chalk graffiti*

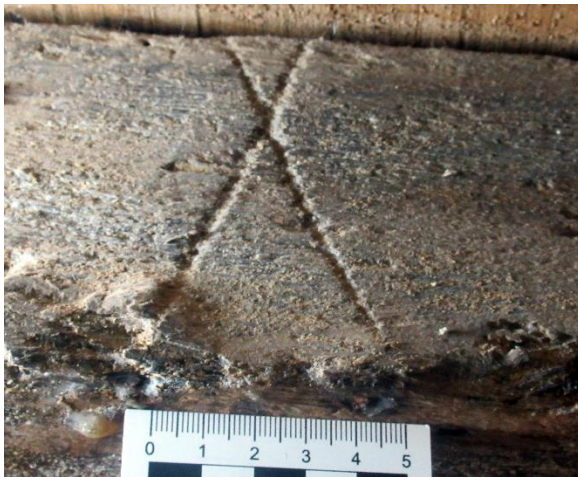
Although no graffiti was found in the front room or shop, the carpenters' assembly marks on the original ceiling joists were recorded. These run in order across the ceiling from south to north, as V, VI, VII, VIII, IIII, X, XI, but with a crossed VII on the first, most southerly joist. (Fig 9) There are no matching marks on the truss, but this had been partly replaced with modern timber.

*Fig 9 Shop. X-shaped carpenter's assembly mark on ceiling joist*

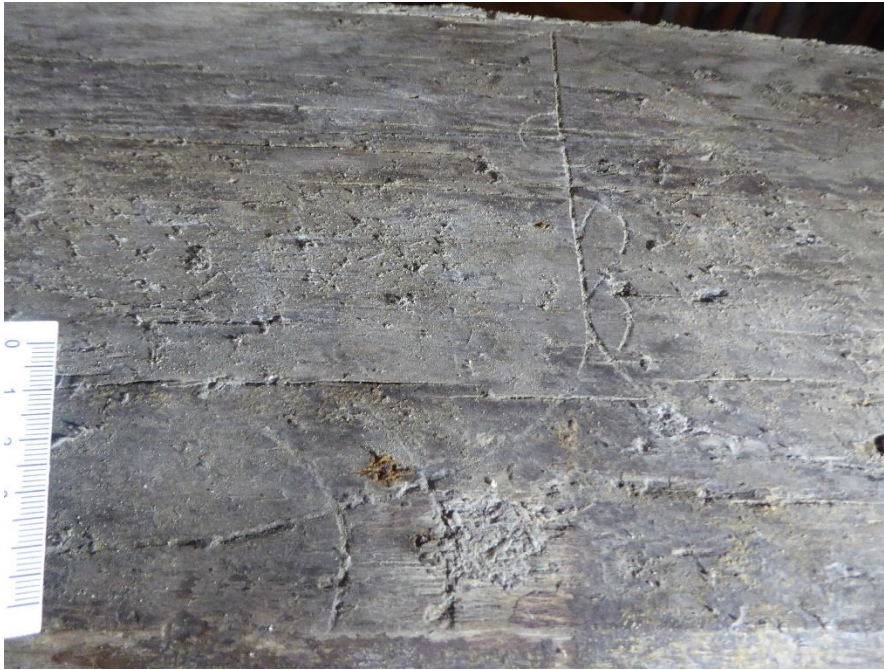
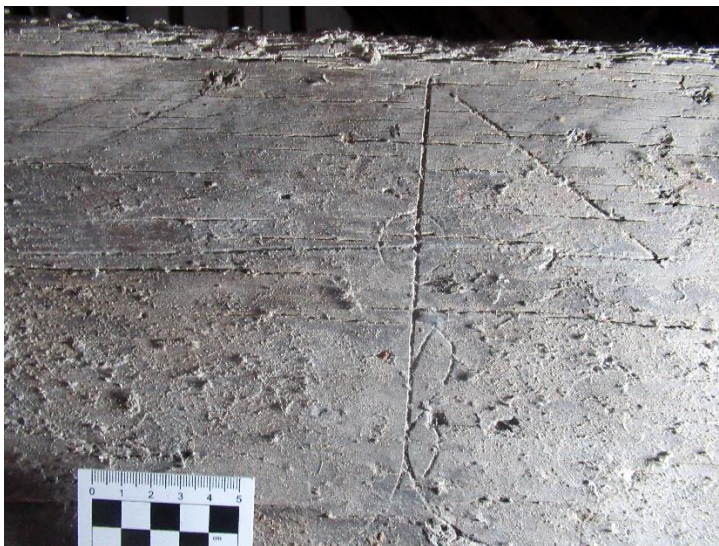
*Fig 12 Front bedchamber. Truss B. Merchant mark, base with extended arm*

*Fig 13 Front bedchamber. Truss B. Merchant mark, top. Reversed 4 shape*

The mark on the east face of the Truss B tie beam (Figs 12, 13) is 2.07m from the north wall. It is above head height, so, assuming floor levels are unchanged, it is in an awkward location to leave a mark. It has the standard vertical upright, with a double looped shape on the RHS and a central circle above this. At the top is the reversed 4 shape which, as well as a normal 4 shape, is found on the majority of merchant marks. It has the characteristic inverted V base, made of curved lines, but one arm extends and has 2 arcs incised across it. If this is part of the original mark it is a very unusual feature. Examples are known of marks being modified when passed on, eg by father to son, so this could be an explanation. Equally, it may be another piece of overlapping graffiti. Merchant marks often incorporated the owner's initials so the double loop could be intended as an initial B, although a study of

photographs taken of the mark, lit from different angles, shows that the loops seem independent of the upright.

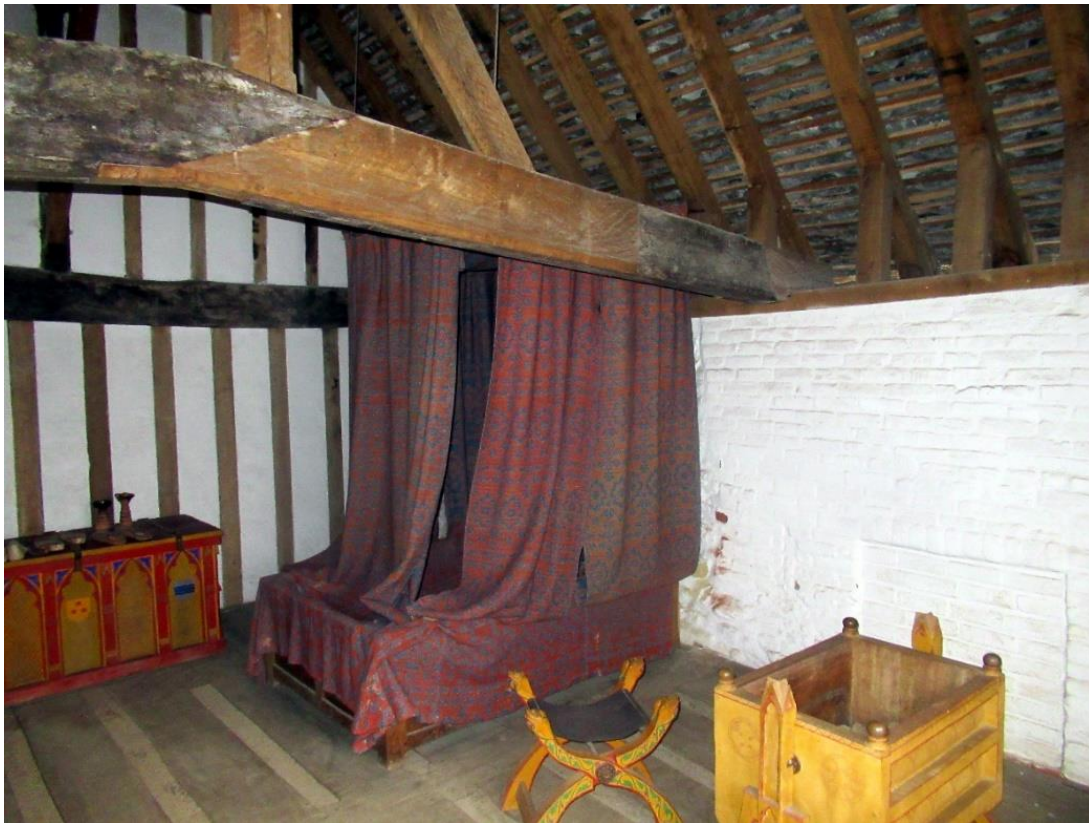
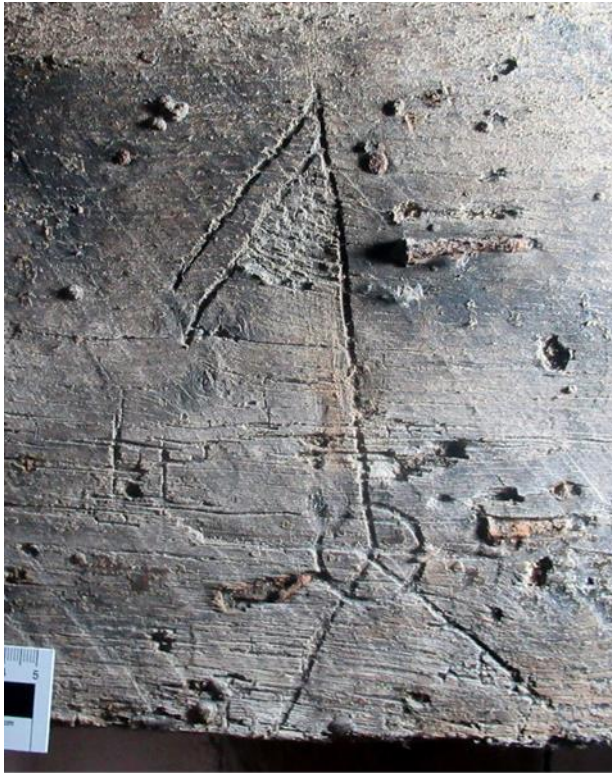
*Fig 14. Bedchamber, tie beam, Truss C*

The mark on the Truss C tie beam (Figs 14, 15) has 2 diagonal lines, known as “streamers” coming from the top of the vertical upright on the LHS. This is another common form of merchant mark. The vertical upright stands on an inverted V base, this time composed of straight lines, with a central circle at the junction.

The different forms of these two marks suggest they belong to different people. The similar locations may be significant. The height of the marks suggests they could have been incised on the beams before the timber framework was assembled.

Fig 15. Bedchamber, tie beam, Truss C. Merchant mark

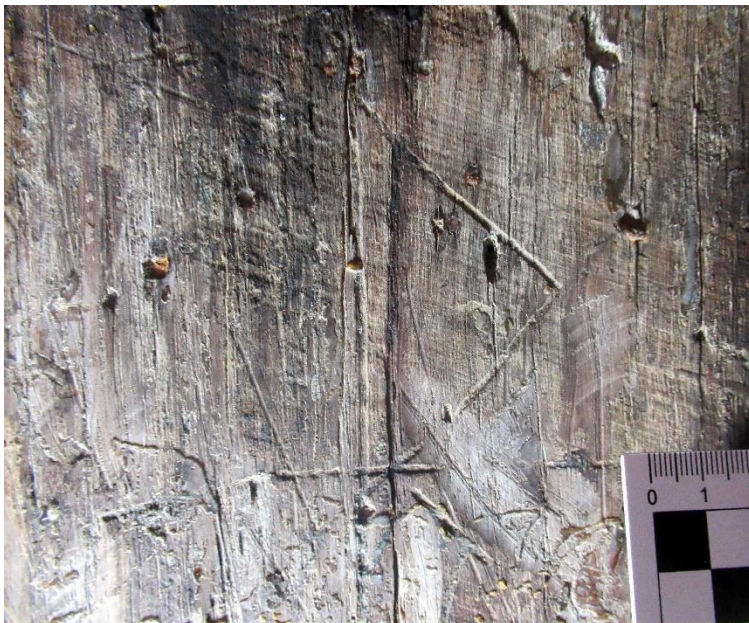
Fig 16 Bedchamber, East window, south side. Lines and shapes

Further marks were noted scratched into the timber stud on the south side of the east window. These consist of overlapping lines and shapes (Fig 16) which may be the marks described in the earlier report as an *inverted black letter 'a' on the inner face of the southern stud against the window.*

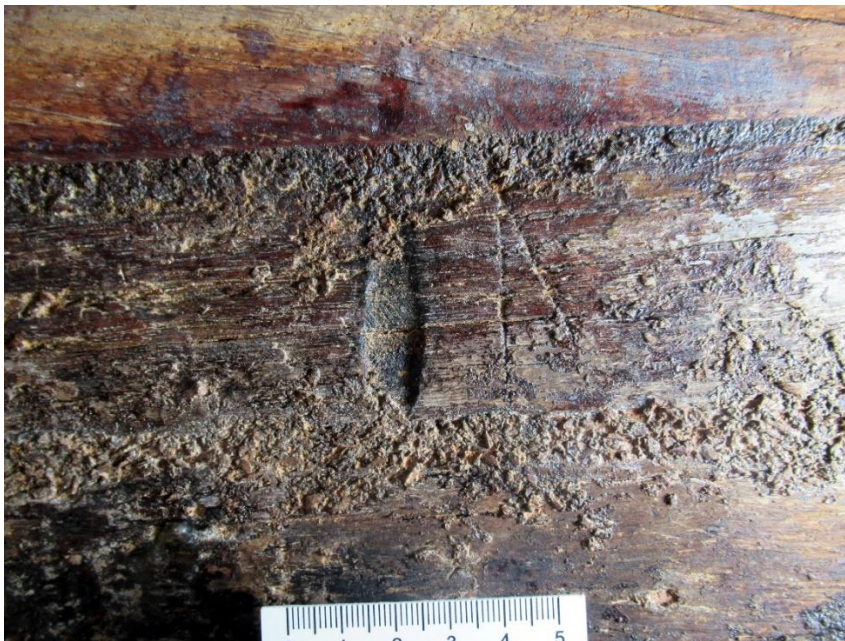
Also recorded were marks known as ritual burn marks. These tear-shaped burn marks are often thought to have been caused accidentally by candles or tapers, and indeed replica iron sconces for tapers now form part of the house's fittings. However, the burn marks identified are not associated with any marks from earlier fittings, and experimental archaeology has demonstrated that many such burn marks were made systematically and deliberately, it is suggested as protection for the building, perhaps against fire (Dean & Hill, 2014). Two examples of these marks were found on the Truss C tie beam, one adjacent to the merchant mark, and another is on the Truss E tie beam, in the rear bedchamber, adjacent to an inverted V shape. (Fig 17)

Fig 17 Burn mark on bedchamber tie beam, Truss E.

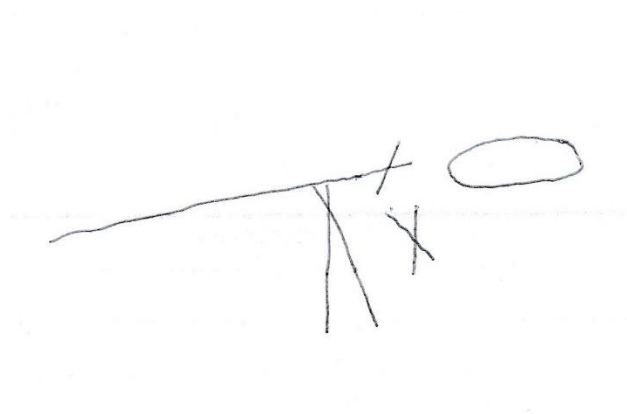
The surface of many of the ashlar blocks forming the vault were obscured with dirt and layers of limewash, but graffiti was found on one block, consisting of incised lines forming cross shapes. A sketch was made of this (Fig 18). Its location, as V1, is shown on Plan 2.

*Fig 18 Vault. Sketch of graffiti in vault, V1*

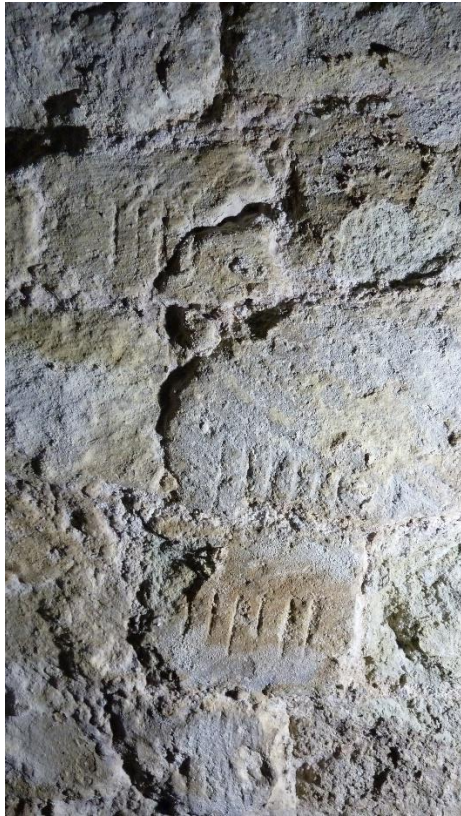
Markings relating to the construction of the vault were found on several blocks. These consist of groups of incised vertical lines, the number of lines indicating the thickness of the stone. These marks were made by masons, presumably off site, to aid with the construction of the vault. (Fig 19). The location of these marks is shown on Plan 2, as V7.

*Fig 19. Vault. Masons' construction marks, V7*
