Cellars at 43, 45, 47, 49 and 51 Bugle Street, Southampton Graffiti report

Summary of findings from surveys on 30th September and 29th November 2022, and 17th February 2023

Southampton Archaeology Society and Hampshire Medieval Graffiti Project

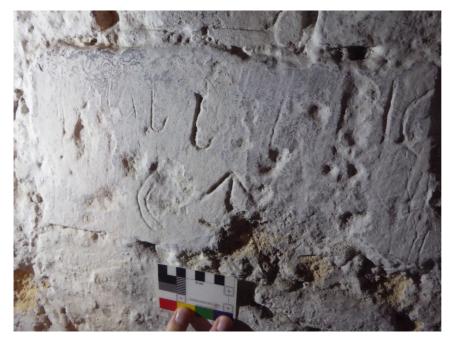
45 Bugle Street Block 2

Block 2 The block on the north wall, opposite the base of the stairs, has marks incised on it. The top left-hand corner is damaged, then emerging from this area, on the top line, is what could be the letter A, its cross bar angled, which would date it to the post-medieval period. Next to this are two curved shapes which resemble fishhooks. The one on the right is more deeply incised. It is possible that these are lower case letter Ls, so this might also represent the end of a word or name ending "all". Or they might be fishhooks.

Beneath these are 2 curved parallel lines and an upward pointing arrow with a horizontal line beneath. On the far-right hand side of the block are what seem to be the initials IC. From an analysis of the names found in Tudor documents from Southampton, listed on the Tudor Revels website, <u>http://www.tudorrevels.co.uk/</u> the most frequent initials are IC. The most common name for men at this time was John. J is represented as a capital I. There are some fine vertical lines beneath which could be accidental, or traces of letters, or perhaps tally marks.

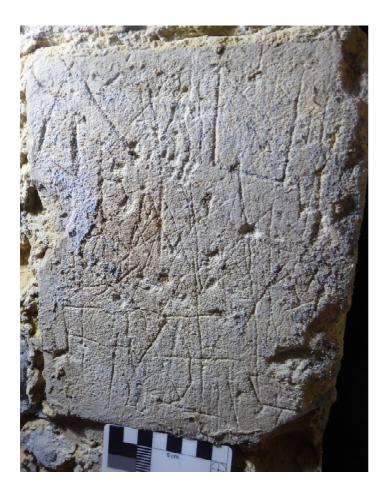
Block 3 In the south-west corner of the part of the cellar extending to the south is a block of limestone with a smooth surface covered in scratched graffiti. Some marks overlie other marks, so it is hard to unpick the individual shapes and to work out the relationship between them.

Whole block

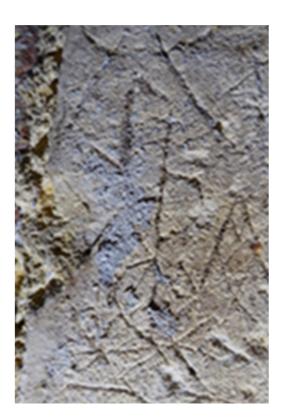
45 Bugle Street

Block 3. Top left corner. Possible merchant mark

On the top left is what could be a merchant mark – a vertical line with semi-circular shapes coming from it. A similar mark was found on one of the beams in the upstairs chamber of the Medieval Merchant's House in French St, Southampton. http://www.chrissellen.taureans.co.uk/index files/SAS/SAS files/Medieval Merchants House graffiti survey summary.pdf

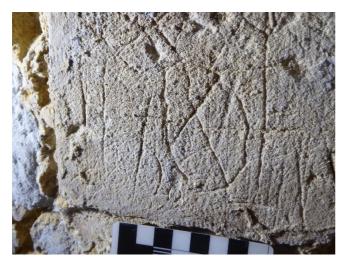
45 Bugle Street

Other shapes could be crosses or initials. There is a circular shape containing a cross at the base of the stone, and geometric shapes, possibly initials.

Block 3. Base. Circular and other shapes

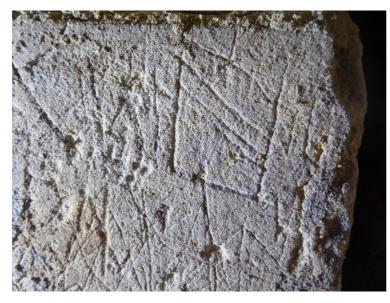
In the top right-hand corner is a rectangular shape with diagonal lines across.

Block 3. Top right corner. Rectangle with diagonal lines

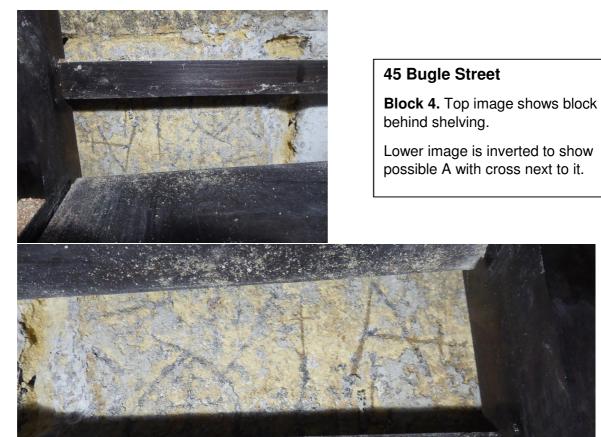
Block 4 This block of stone with graffiti on it is in the south-east corner of the main body of the cellar. It is obscured by shelving which we did not remove, so full interpretation of the marks is difficult. However, the V shaped mark makes more sense as an A, with an extension of the horizontal bar ending with a crossed shape, so perhaps the stone is reused and has been set upside down within the wall. This was common practice and examples of reused inverted stones can be seen in many buildings, for example in Southampton's Wool House (Dancing Man pub) next to a window in the south wall a stone incised with a French inscription is preserved, but upside down.

There is a finely carved cross next to the V/A shape. Crosses are commonly found as graffiti, usually around the entrances to churches, and probably left by worshippers as signs of personal devotion. Whether this cross has similar religious connotations is open to speculation. The larger shape on the other side of the block is obscured by the shelf so is difficult to interpret.

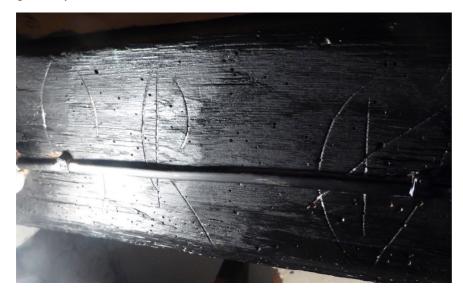
45 Bugle Street

Beam 5 Some scratched shapes can be seen on a wooden beam which is covered in black paint and has electric cabling running to a light bulb fixed on it. The shapes can be seen beneath the cabling. One is a circular shape with a cross inside. Another could be the letter R, possibly someone's initial. The beam is probably post medieval in date. The graffiti predates the electrical works.

Beam 5. Circles and possible R

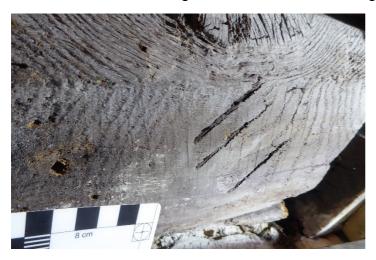
45 Bugle Street

Beams 6 and 7 appear to be original medieval timbers and have carpenters' assembly marks on them. These marks were made before the timber frame was finally constructed on site. The timbers were originally assembled offsite, and the frame pegged together temporarily. Joints were marked and numbered with a race knife, to show the location of joining timbers, and the order in which they came. The numbering system was based on Roman numerals and Beam 6 has three straight lines on it. A more elaborate group of marks is seen on Beam 7, suggesting a higher number in a sequence, or perhaps it includes marks indicating which level of the building this timber belonged to.

Beam 6. Carpenters' assembly marks

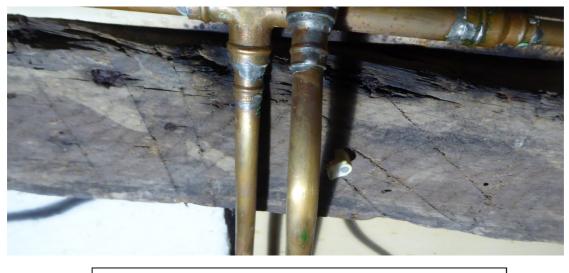
45 Bugle Street. Beam 7. Carpenters' assembly marks

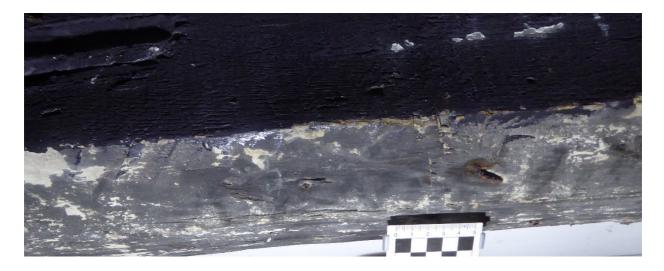
There is what appears to be lettering formed from soot, running along the side of the beam near the base of the staircase in the area of the cellar which was burnt. The forms of the letters are indistinct and indecipherable.

47 Bugle StreetGraffitiLettering written in soot, in burnt area of cellar

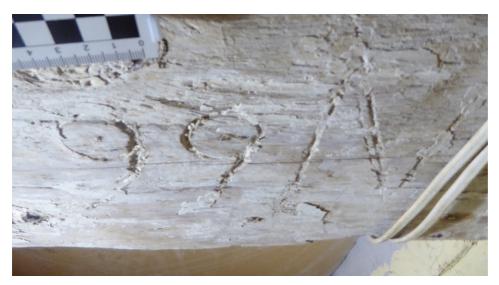
At the west end of the beam are carved what appear to be two numbers, either sixes or nines, their circular component made by compasses or dividers, with a central hole evident. They are deeply cut and filled with later limewash or paint. Next to the numbers is a shape which could represent the letter N. This may represent a port mark, the Russian and German ports of shipping were often represented by a mark consisting of letters and numbers.

49 Bugle Street Timber mark 1 Possible 99 N or N 66

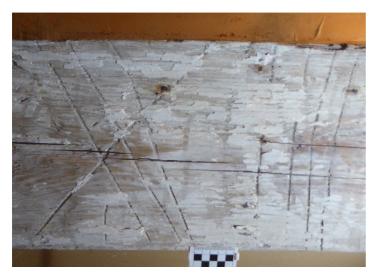
In the central area of the beam some lines are incised. These marks are possibly batch marks and may also identify the quantity of timber present. There are three diagonal lines with one line across next to four vertical lines. This could represent the number 34.

49 Bugle Street Timber mark 2 Baltic timber batch marks

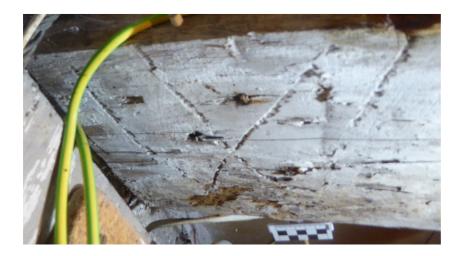
At the east end of beam is a W shape made of two interlocking Vs. There are various possibilities for the meaning of this mark. It could be an initial W, representing someone's initial, perhaps used at the timber yard. If a Baltic timber marking it could have been made to identify the exporter. Or it could be a type of apotropaic or ritual protection mark, often found in buildings from the 17th century onwards, made to ward off evil spirits. The shape is derived from a symbol of devotion for the Virgin Mary, the two Vs standing for *Virgo Virginum*, Virgin of the Virgins. After the Reformation, the symbol gradually lost its religious significance, becoming more of a good luck charm.

49 Bugle Street Timber mark 3 W shape

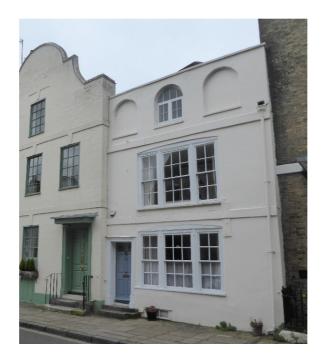
51 Bugle Street.

The cellars here have been brick-lined and painted throughout, so no traces of any earlier graffiti survive. The sturdy timber framework is still exposed, and on the north side of the doorframe into the front cellar area are some carpenters' assembly marks, in the form of three horizontal lines (probably Roman numeral for 3, when vertical). Originally, the timber framework would have been assembled elsewhere and the timber joints marked for ease of construction on site. This mark would have had a corresponding mark on the timber which joined it.

Door frame, north side.

Carpenter's assembly marks
