## **EXCAVATION AT HURSLEY PARK 2021 – INTERIM REPORT**

Winchester Archaeology and Local History Group (WARG) undertook a two-week excavation in August 2021 in the grounds of Hursley Park, at the invitation of the landowners IBM. Parch marks in the lawn to the south of the current 18<sup>th</sup> century house had indicated the possible location of an earlier substantial building. Detailed documentary research by David Key (IBM volunteer historian) strongly suggested that this represented the remains of a Tudor house which was demolished when the 18<sup>th</sup> century house was constructed. The site, centred at NGR: SU 4225 2537, is situated to the south-west of Winchester on the edge of Hursley village.

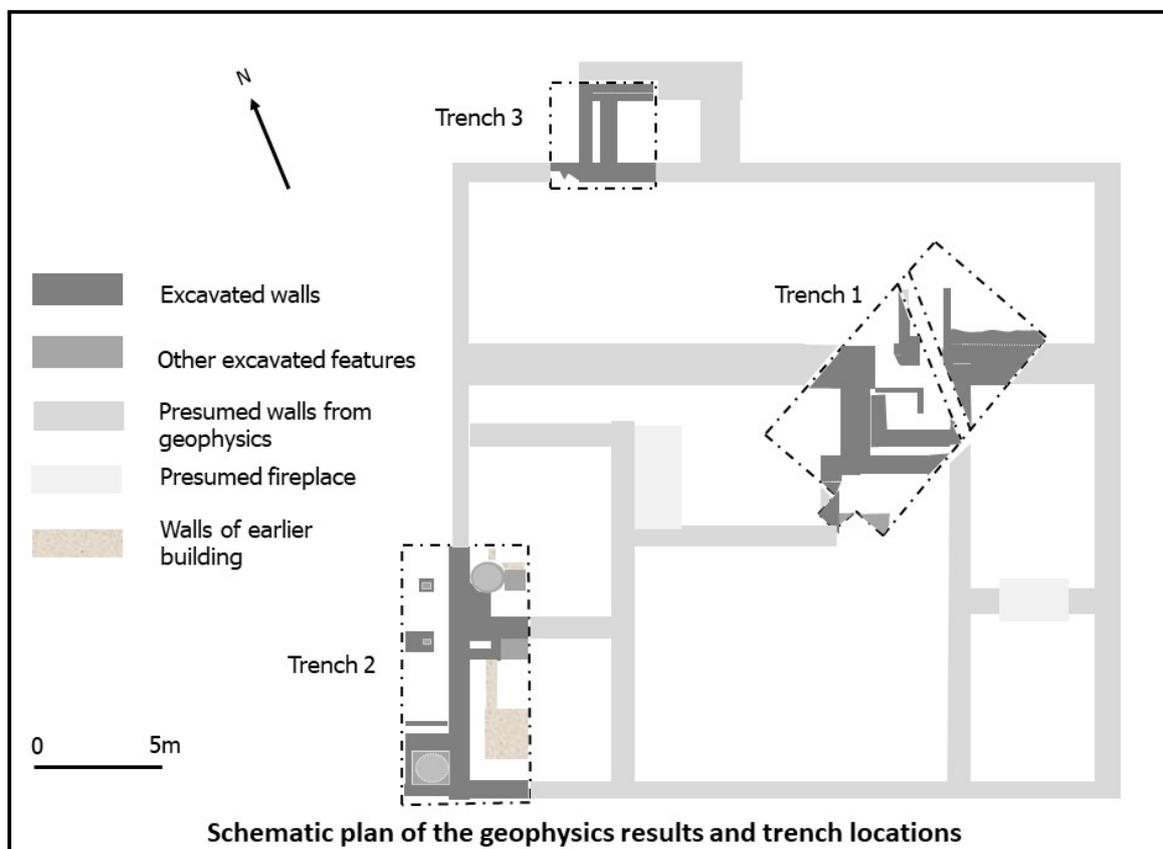
Prior to excavation a geophysical survey was undertaken using both soil resistivity and ground penetrating radar. The results confirmed the presence of a substantial building, indicating a rectangular north range c.30m long by 9m wide, parallel west and east wings projecting to the south c.14.5m, each wing 7.5m wide, with an enclosed area between them. This informed the trench locations.

Three trenches were opened. Trench 1 (10 x 6m) was sited over the north-east corner of the building to take in a large high resistance anomaly and a number of walls. Trench 2 (10 x 5m) targeted rooms at the south-west corner of the building including two high resistance features that could be fireplaces. Trench 3 (4m x 4m) was positioned to explore a rectangular feature extending beyond the assumed front of the building. The turf and remarkably clean topsoil were removed on each of the trenches (**1001, 2001, 3001**) to reveal a layer of gravel (**1004, 2002, 3002**) which had been imported to the site and contained a quantity of worked flint. The gravel was laid across the site to a depth of 50-120mm presumably to provide a free-draining, level substrate for the lawn. Demolition material came from both the gravel and the lowest levels of the topsoil as a result of settling and bioturbation over time. One modern feature was encountered: in Trench 1 a plastic drainage pipe with rodding point bisected the trench N-S (**1002, 1003**). It had presumably been laid using a mole borer as no cut was visible in the topsoil and it had disturbed the archaeology to a depth of c.0.50m. To protect the pipe a 0.50m baulk was left in place. During the excavation none of the exposed walls or wall footings were dismantled.

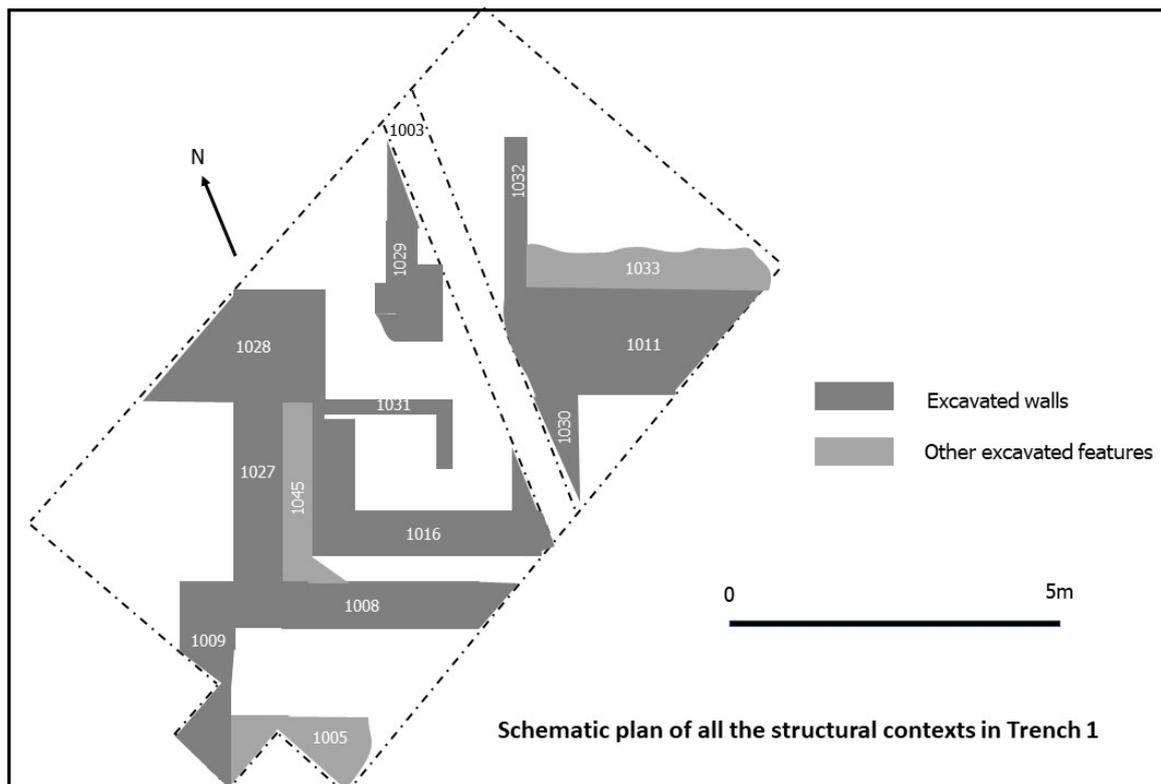
**Trench 1**

Removal of the gravel revealed the tops of a number of brick structures separating areas of demolition material which in places was up to 120mm deep and overlay further walls and intervening surfaces (**1010, 1015, 1019**). In the area of the geophysical anomaly the demolition material was of a greater depth and consisted of larger pieces of masonry and

In the wall plan revealed by removal of the demolition deposits the dominant feature was an E-W wall (**1011, 1028**) with a maximum width of 1.6m, corresponding to the south wall of the north range identified on the geophysics. The wall was interrupted at a point where three walls delineated a rectangular projection to the south measuring 3.5m N-S and 5.0m E-W externally. The eastern wall of the projection (**1030**) is in all probability the west wall of the east range shown on the geophysics. Therefore, this rectangular structure sits in the angle between the north range and the east wing. The south and west walls of the structure (**1008, 1027**) were 0.8m wide. The depth to the basal mortared flint foundation of **1008** was 0.3m from the top remaining brick course. There was a curious arrangement whereby an inner wall (**1016**) which was 0.65m wide, 0.45m to the pebbly mortar basal foundation, sat inside **1008** and **1027** with a gap of 0.35 – 0.40m between. The gap was filled in places with brick rubble and mortar (**1045**) and elsewhere by pre-existing soil. If not integral to the original design, this could be evidence for the alteration or strengthening of the building at this point. The rectangular area enclosed by these walls (1.56m N-S and 1.20m E-W) was filled with a silty pre-existing soil (**1012**), against which the walls had been built as evidenced by the poor finish and dribbles of mortar on their internal faces. **1012** was bounded on the north and partially on the east by a narrow retaining wall one brick wide (**1031**). A sloping surface cut into **1012** led directly towards the cellars/lower ground floor rooms and this lends weight to the interpretation of the rectangular projection as a stairwell, with the slope giving an indication of the angle of the stairs.

The stairs gave access to two corridors at the lower ground floor level, both 0.75-0.85m wide. From the foot of the stairs the eastern corridor continued due north while the western corridor turned a right angle west then north around an island wall (**1029**) before opening into a larger space or room. **1029** was wider at its southern end in line with the main house wall, presumably to support a lintel bridging the gap. Near the south entrance to the easterly corridor a door jamb was recessed into both of the flanking walls (**1029, 1032**) and beyond this the corridor widened to 1.25m. All of the walls associated with the corridors and lower ground floor rooms were rendered and plastered to a smooth flat finish, this even extending into the door jambs.

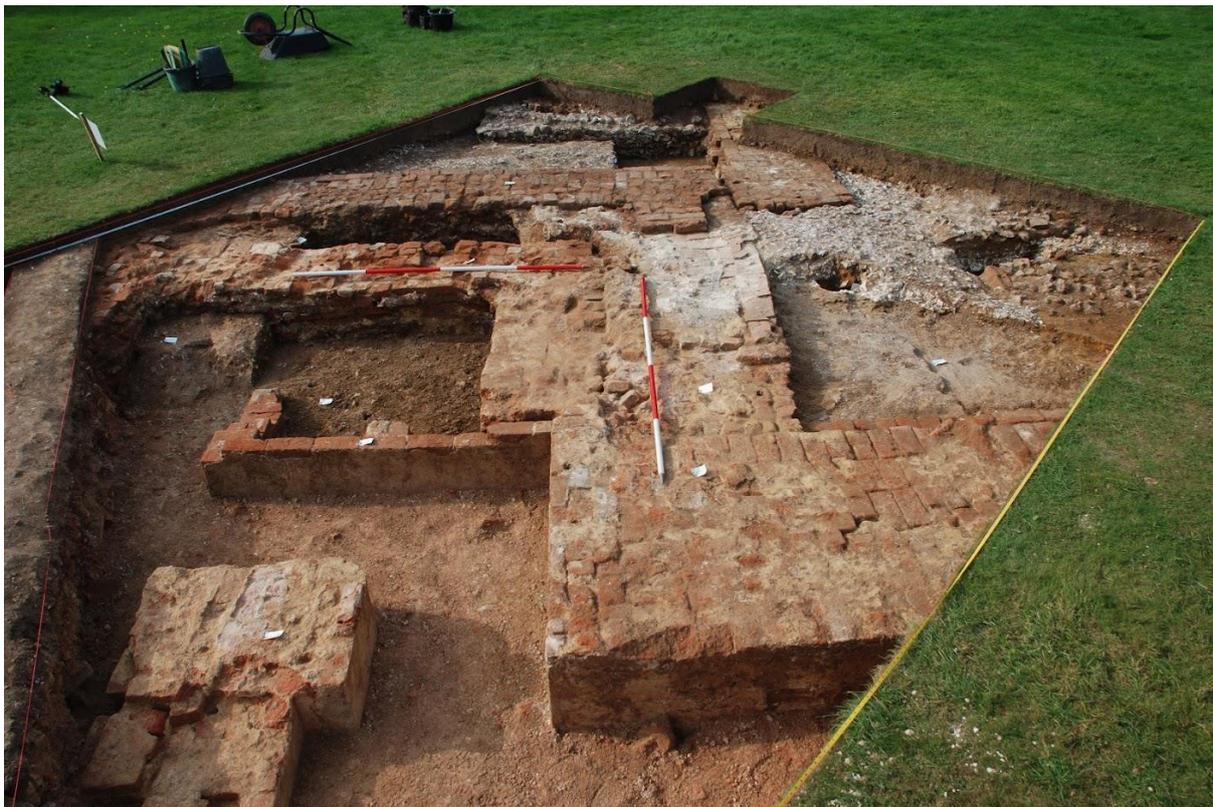
### Trench 1: facing south (west of the modern pipe trench)

From the south-west corner of the stairwell, and bonded to it, wall **1009** (0.8m wide) extended due south to the edge of the trench. Bonded to **1009** and projecting from it at a right angle was a mortared flint platform (**1005**), 2.25m E-W (the dimensions N-S are beyond the trench edge). The flint nodules are poorly sorted (max 230mm x 180mm, min 110mm) and chalk appeared to have been rammed into the top surface. Towards the eastern edge of the platform and occupying a hollow within it, was a small area of unmortared bricks laid on edge and tightly set in six rows (**1006**), on a bed of yellow sand <10mm deep (**1042**). The bricks were soft and broke when lifted. To the side of the brick rows was a tumble of similar bricks which were not underlain with sand. A slot revealed a clayey silt soil (**1043**) underneath the sand. A chalk surface (**1013**) filled the space between the flint platform and the stairwell wall. The chalk particles ranged in size up to a maximum of 80mm and were set in a silty sand. The chalk surface was deepest to the north (max 80mm) and it thinned to the

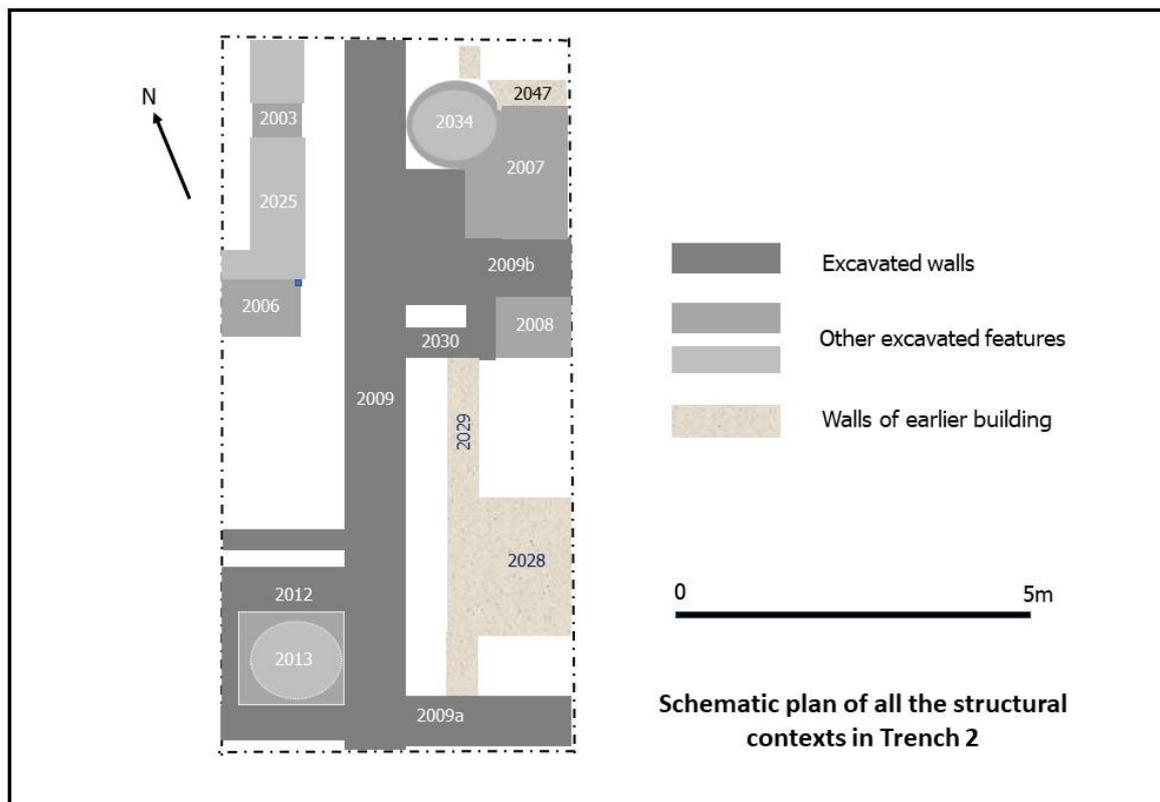
### Trench 2

The gravel in Trench 2 was underlain by a demolition deposit up to 80mm deep (**2005**) and when this was removed the dominant feature was a N-S wall (**2009**). This extended from the north baulk to within 0.25m of the south baulk where it turned a right angle, corresponding to the south-west corner of the west wing as depicted on the geophysics, before disappearing into the eastern baulk as wall **2009a**. Three metres south of the north baulk a spur from **2009** also projected eastwards into the east baulk (**2009b**). At the southern end of **2009** a small structure measuring 2.4m N-S and more than 1.6m E-W abutted it to the west. It was delineated by wall **2012** and inside there was a circular brick setting (**2013**) 1.2m in diameter. This showed evidence of burning and may have seated a large vessel or copper for heating water in relation to an activity such as laundry or brewing.

Wall **2009b** is a dividing wall between two of the rooms in the west wing with back-to-back fireplaces either side of it. The fireplace to the north (**2007**) was 1.6m wide and more than 1.1m long. It was constructed of brick and covered with blackened sand. To the west of **2007** was a sub-circular brick-floored structure 0.7m in diameter which may represent the base of an oven (**2034**). The fireplace to the south (**2008**) was 0.9m wide and more than 1.4m long disappearing into the east baulk, and was constructed of tiles on end with blackened sand between them. To the west of **2008** and occupying the angle between **2009** and **2009b** was a small enclosed space or cupboard 0.5 x 0.7m defined by wall **2030**, which had a chalk floor and a threshold to the south. The southern room, between **2008/2030** and **2009a** had a hard clay floor up to 0.35m deep (**2014**), this extended underneath fireplace **2008**. In the south-west corner of the room, c 0.4m from the walls but not parallel to them, a curious small brick-lined structure (0.35m square) had been sunk into the floor (**2042**). It is suggestive of a place of concealment. The contents included material that would not be out of place in the demolition deposit, but mixed with this was a concentration of metal objects including a small annular gold fitting/finger ring.

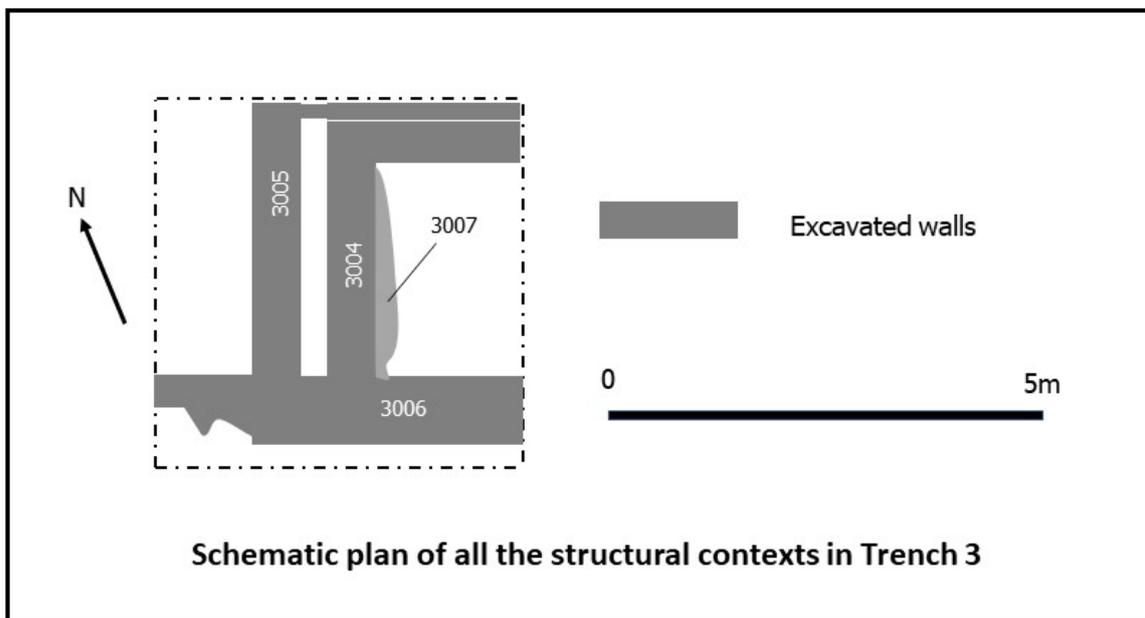
### Trench 3

Removal of the gravel revealed an E-W wall (**3006**) corresponding to the north wall of the north range as depicted faintly on the geophysics. It was 0.8m wide and a sondage (1 x 0.2m x 0.4m deep) against the south face revealed six courses of bricks above a basal foundation of mortar and flint c.0.4m below the top surviving course. The sondage was cut through demolition deposits the depth and nature of which suggested that it may have filled a cellar/lower ground floor room similar to Trench 1. However, the relatively shallow foundation of **3006** calls into question the possibility of a lower ground floor room here. There appeared not to be a plaster finish to the interior face of **3006** which also argues against this being the wall of a lower ground floor room.

Recessed into **3006** at the western end of the trench was a window sill, 0.35m wide and >0.6m long before it disappeared into the western baulk. The sill was composed of two blocks of non-local stone, the completely exposed block being 0.45m long. These were chamfered on the north and south faces, with a moulding at the eastern end. A rough groove along the centre line, together with a square-section hole where the two blocks join, are indicative of glazing. If the lower ground floor rooms did extend to the front of the building this could be one of a series of windows that lit these rooms. Conversely, if the rooms at the front of the house were at ground floor level it is possible that the window sill had been re-used as a door threshold.

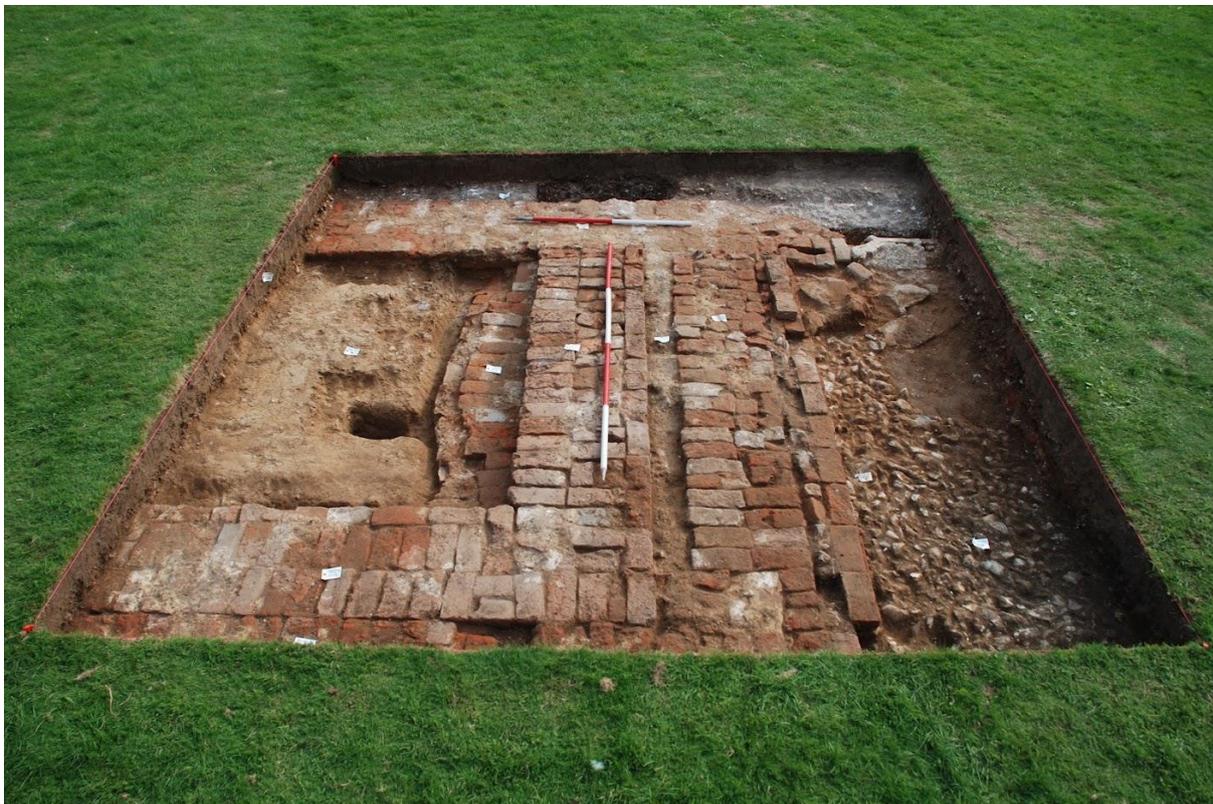
### Trench 3: facing south

To the east of the flint surface and paviments was a wall (**3005**) which abutted **3006** at a right angle. Wall **3005** was 0.7m wide and after 2.8m it turned through 90° to the east where it continued for 2.2m before disappearing into the eastern baulk. The geophysics suggests that there was a return wall creating an enclosed rectangular space. A second wall (**3004**), 0.6m wide, sat inside **3005** in an arrangement similar to that encountered in Trench 1. On the western arm of the rectangle, the space between **3005** and **3004** was 0.2m wide and filled with mortar. On the northern arm the two walls were abutted closely together leaving no space between them. The area within the rectangle was filled with a reddish orange clay (**3003**) and a small sondage which did not bottom it revealed its depth to be >0.20m. When **3003** was partially removed alongside **3004** it exposed a layer of mortared brick (**3007**) at least two courses deep. It appeared to be a stepped foundation to **3004** which extended along the full length of the western arm, protruding to a maximum of 0.4m. The function of the rectangular extension is unclear. It is not central to the building but nevertheless could be the foundation of a portico leading up to the main front entrance. Alternatively, it could be the base of projecting bay windows, in which case there would likely have been a twin the other side of a central entrance which has not been picked up by the geophysics. WARG intend to return to this area in 2022.

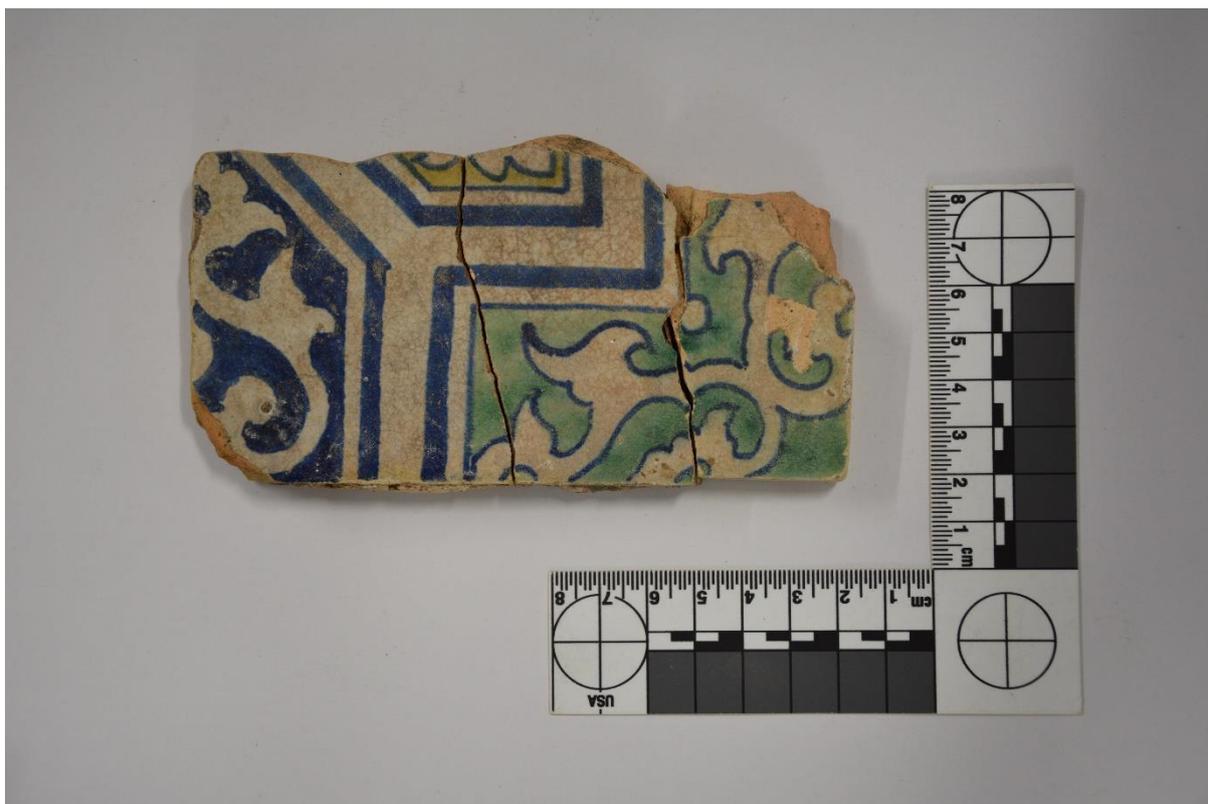
Polychrome tile from Trench 2

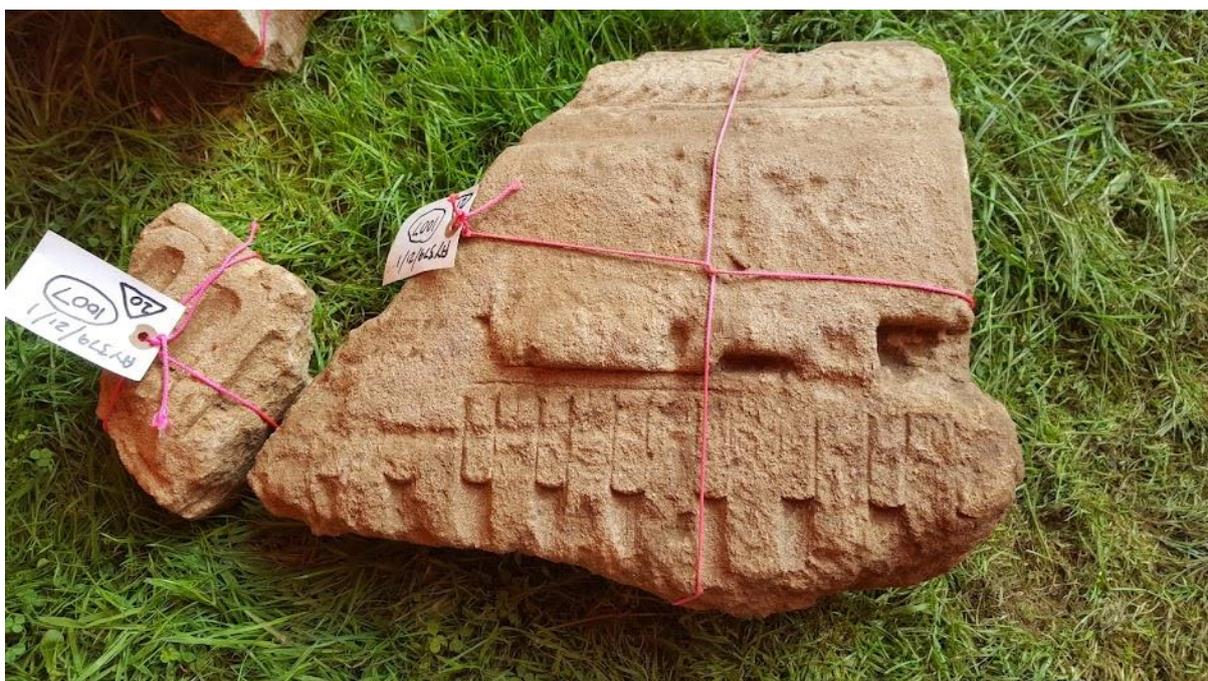
Decorated masonry from Trench 1

Most of the finds of materials used in the fabric of the house came from the demolition deposits. It is important to remember that what survives on site is likely to be the 'dregs' of the demolition process, with documentary evidence suggesting that there was extensive re-use of materials in the new house. However, the fragments that were found provide important architectural details. Evidence for flooring materials, of which none were found *in situ*, took the form of limestone paving slabs and black-glazed floor tiles. Numerically the former dominate, but this may reflect the selective re-use of glazed floor tiles over limestone slabs. The building was roofed with clay tiles (280x178x14mm) with examples of both round and square peg holes. There was one piece of a cock's comb ridge tile. Nearly 3.5kg of slate was recovered from the site, but the average size of the pieces was just 15g and no peg holes were found so it is unclear whether these derive from roofing material or the slate was used in some other way. A few pieces of decorative brick were found, and there were many vitrified bricks which could have been used for patterned brickwork. The windows were leaded and glazed although no complete panes have been found. There was very little window lead amongst the demolition and several pieces were in a semi-molten mass indicating that the lead was probably melted down on site possibly for re-use in the new house. A few pieces of decorated masonry indicate the use of carved stonework for interior features such as fireplaces, and fragments of polychrome tile with geometric and foliate designs add colour to the interior decoration. A gilt lead mount in the shape of a six-pointed star again gives a hint of decorative detail.
