WARG Excavation 2011 - Saint Elizabeth's College

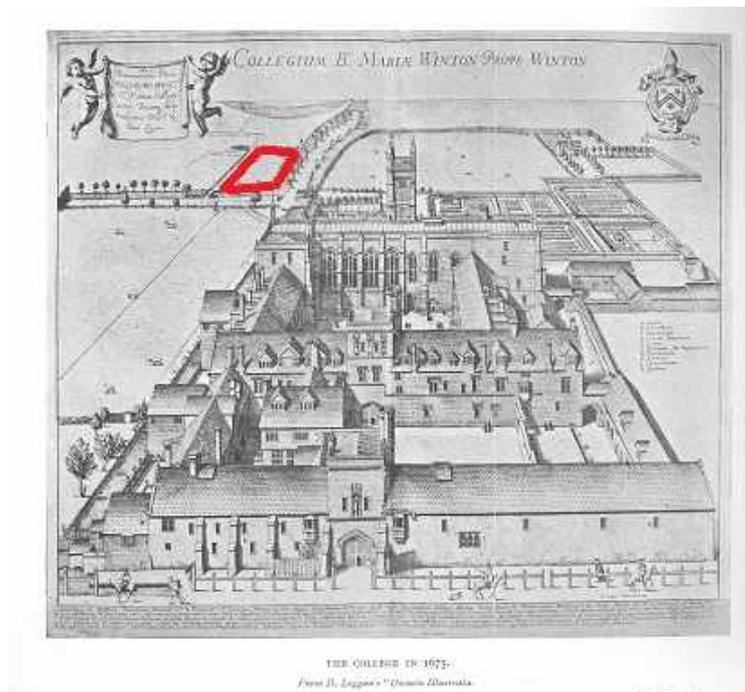
After Leach

The chapel was to become an integral part of Bishop Wykeham's new college and remained so until The Dissolution when Thomas Wriothesley acquires the site, like many others in Winchester, and systematically demolishes the buildings, which leads to the selling and much re-use of the materials in the local area. This 1675 "map" shows the chapel site – note the trackway to its east (left).

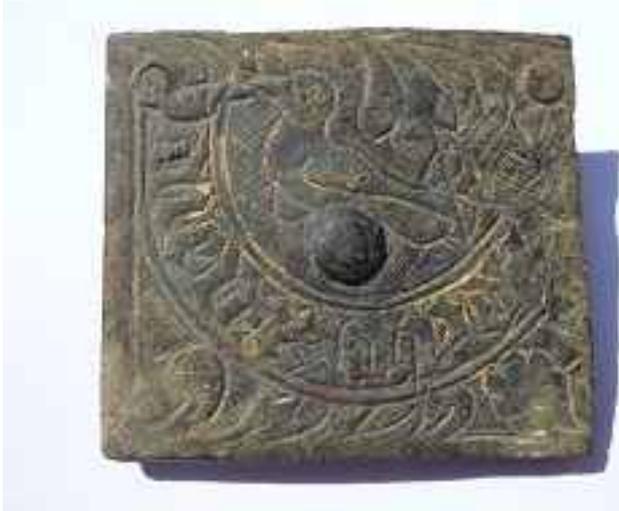
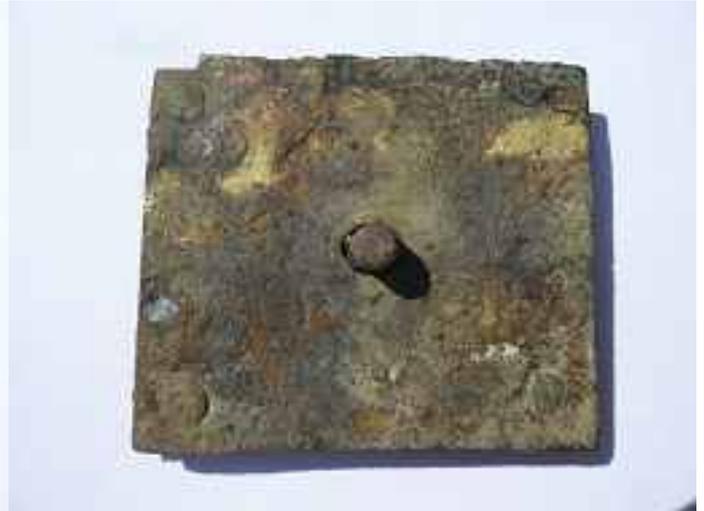
It's reproduced here so that you can either join the debate or come up with the answer. No prizes offered I'm afraid. The piece is two squares of a bronze alloy (like brass), perhaps gilded, separate by a sliver of leather. There is a large rivet through the centre, though the two pieces are actually held together by four smaller rivets at the corners. The two pieces appear to be a piece or pieces of reused metal and the designs on both sides may be coincidental. Any suggestions to webmaster@warg.org.uk.

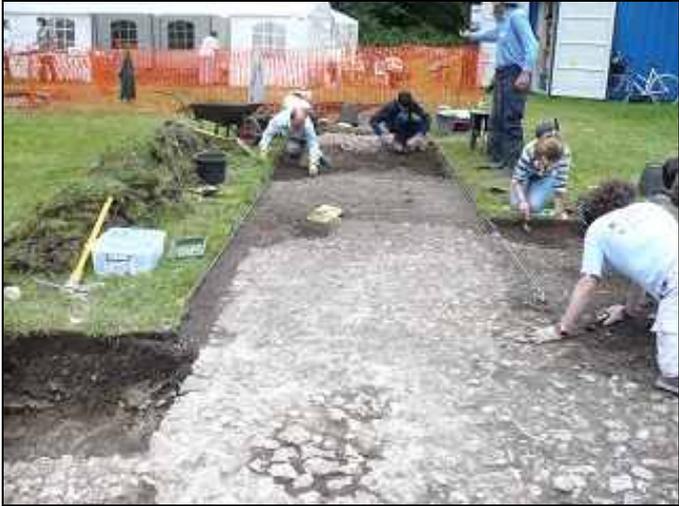
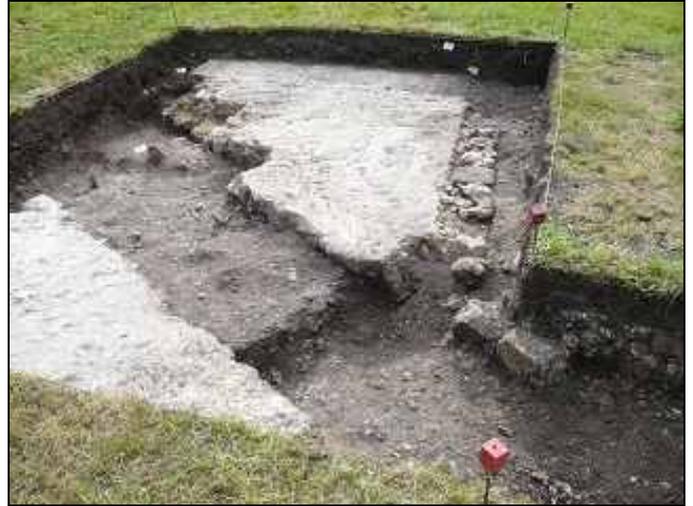
The west wall showing the gap for the door (Tr9), and the sewer cut through the north wall (Tr2)

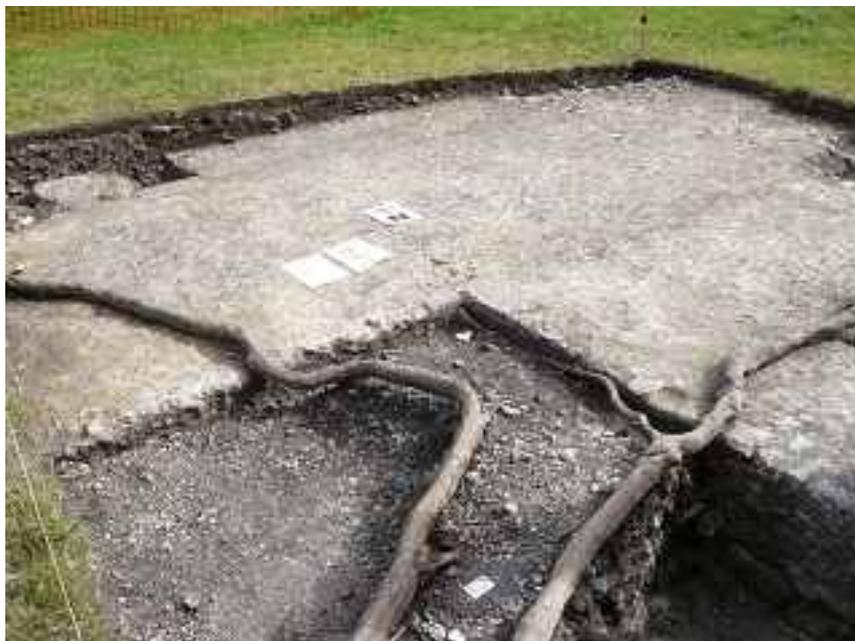
Trench 1

Over the north-east corner a very clear cruciform was exposed, which was the top of the mortared foundation. Each corner of the cruciform had blocks of dressed stone (Greensand) which are likely to have been placed more for planning in the building phase rather than for any structural purpose. Such blocks were found to a greater or lesser extent in each of the four corners. A section of the inward facing foundation was examined to establish the chalk platform and the blocks above it. This section was taken down to the alluvial level.

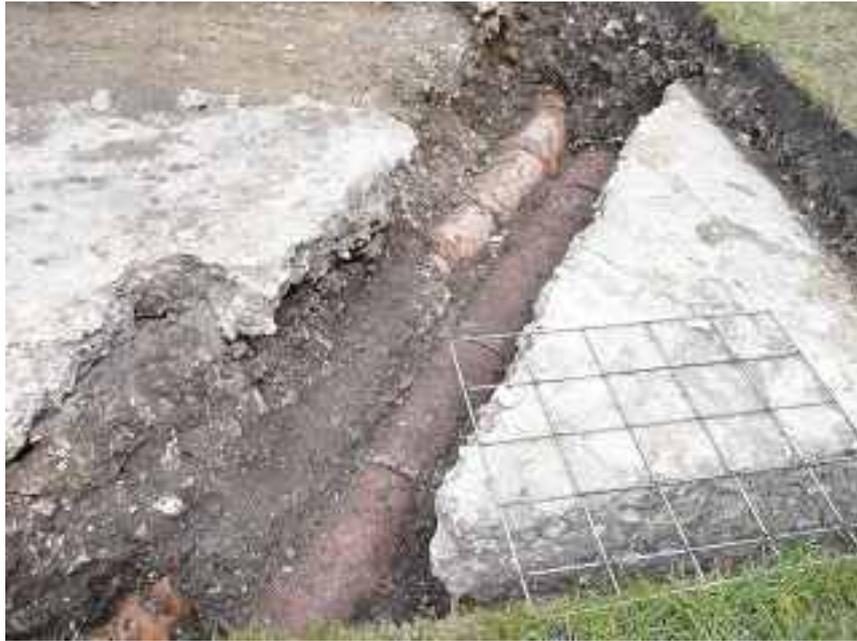
Trench 2

The original objective of exploring a wall section was achieved in the second week when Don Bryan joined the dig, as he extended the trench southwards and westwards. Indeed both internal and external wall faces were established, the buttress (the only non-corner buttress) and the wall section where BOTH the sewer pipes cut through. One of the pipes, composed of pipe sections with butt and socket joints, was either a sewer or a drain. The other lacked socketed joints, having instead intentional gaps between pipe segments, was more likely a local land drain. Water was seen inside this pipe after rain.

The early finding of some unstratified and unarticulated human bones in this trench is thought to be earlier burials in the then-sanctified ground which had been disturbed by and part of the fill of the work to install the later sewer pipes.

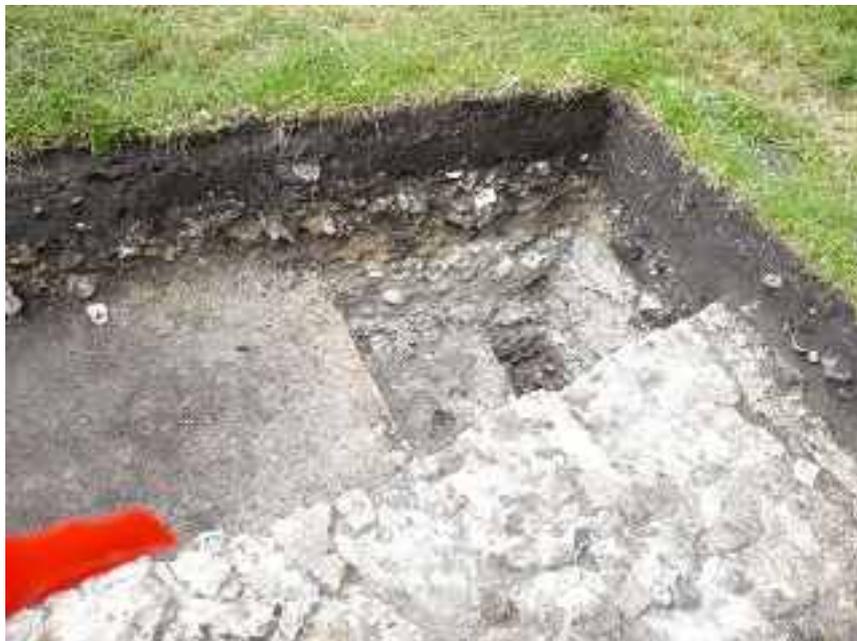
Trench 3

Originally close to the south-east corner this trench produced the first clear view of the foundations and the way they had been built into the chalk foundations. We can see various layers, the foundation wall, the chalk platform, chalk rubble, then the alluvium layer. The puddle at the bottom is actually water that had either seeped in from the sides, or the water table itself (bearing in mind this is August). A most satisfying trench for Geoff Ellis, who was to see it extended into Trench 9 as the dig progressed.

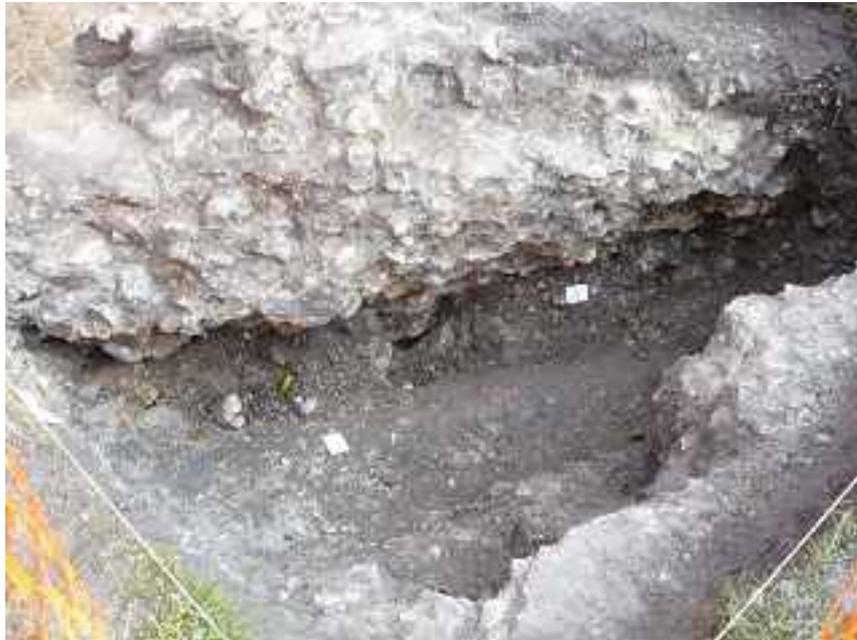
Trench 4

Dug to seek the section not initially possible in trench 2 due to the delay caused by the bone find, the trench quickly identified part of the wall, the mortar top to the foundations, the foundations themselves and chalk rubble. All this, of course had been cut by the rather large sewage pipe. We were calling it that but in fact a close look at Winchester City Council's GIS

system showed that Southern Water knew nothing of this pipe, let alone pumped anything noxious through it. So its provenance and purpose remains unknown.

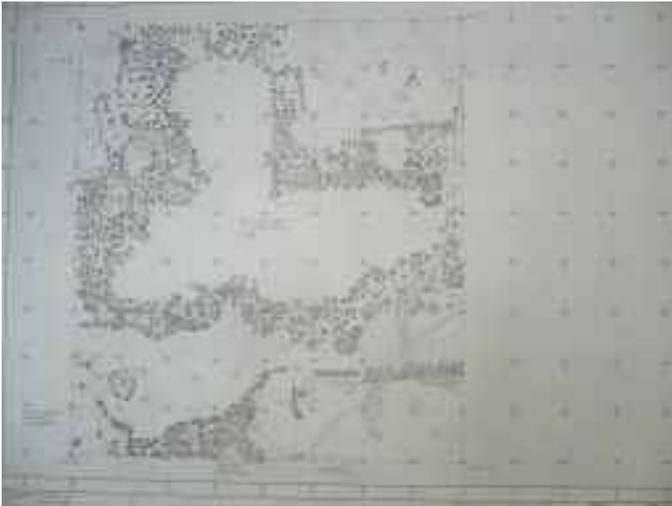
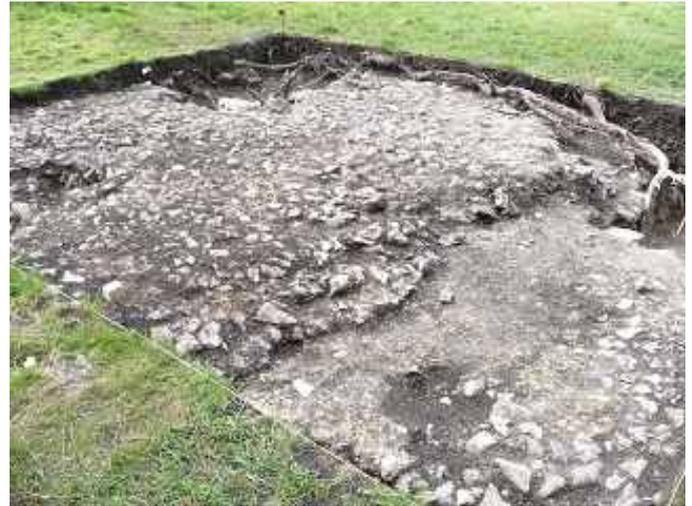
www.warg.org.uk/home_files/Trench-7-plan.jpg

The trench identified the south-east corner of the chapel. There was more wall remaining on top of the foundations and the corners again showed the use of dressed stone. Again the question, construction alignment or structural – or even decorative. Tantalisingly the interior east wall, where we would expect to find the altars, had some evidence of a recess in the wall, perhaps where another stone structure had been keyed in. One of the three altars, perhaps.

All this detail has been presented in WARG's highly professional manner – producing an archive for further research – and all done by volunteers, many of whom were new to the techniques used. This plan of the trench by Lucy Sharp illustrates the record, which is allied with photography and the written context sheets to provide a detailed description of the trench.

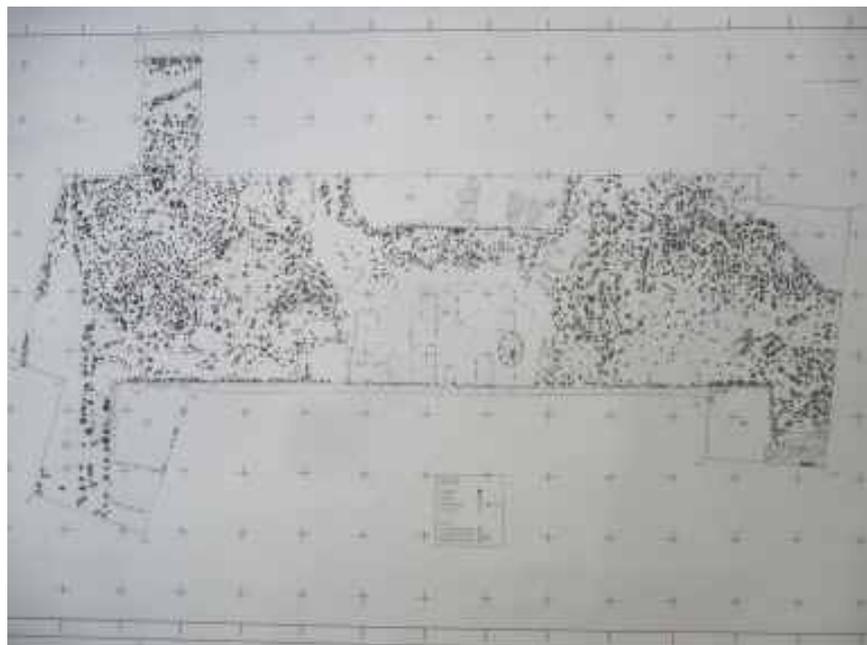
www.warg.org.uk/home_files/Trench-9-plan.jpg

The trench that just had to be dug. Positioned over where the west door would be, the geophysics had predicted two massive structures either side of the door recess, and they duly obliged. No only that but the door recess showed how the entrance was funnelled towards the door, and had residual mortar shapes indicating where paving slabs had been laid leading up to the doors themselves. This can clearly be seen on the plan.

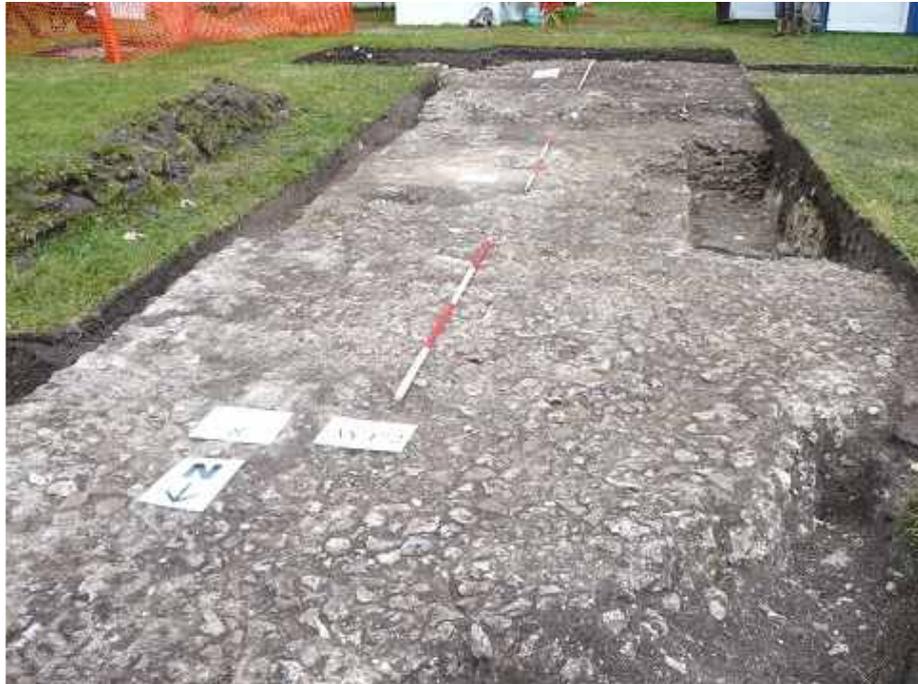
The final oddity or irony in the trench was the finding of dressed limestone blocks abutting the entrance way in a curious parallel manner. Various conjectures were made but the most likely explanation is that there is a grave, orientated west-east, using the west end of the chapel as the end of the grave markers.

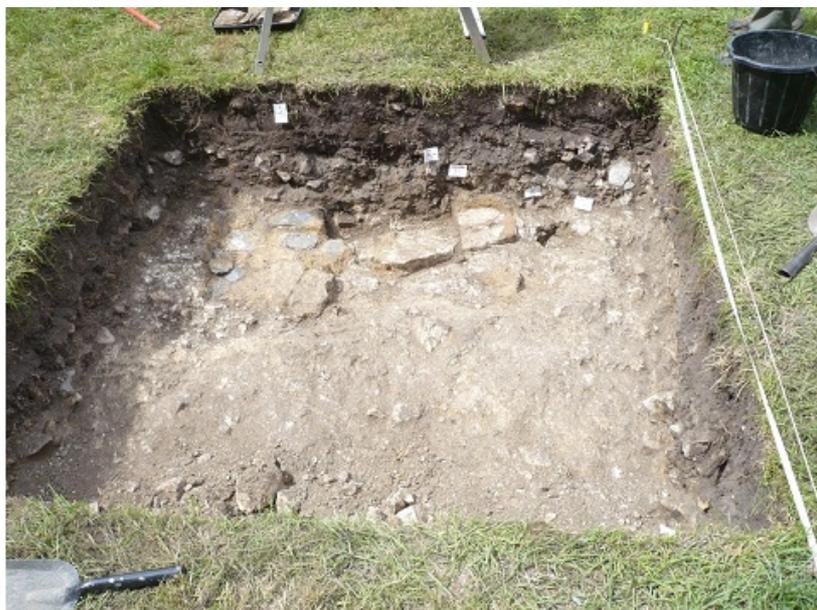
Trench 10

Our final trench was placed slap-bang in the centre of the chapel, in an attempt to prove the extent of the chalk platform, and look for evidence of any of the interior floor remaining. What was found was most exciting, as medieval floor tiles, together with slate were encountered quite near the surface. To cap it all, further dressed stone in the shape of the foot of a coffin were also unearthed, suggesting that the inside of the chapel was a place for the departed clerics and priests to be buried.
