**Medieval Merchant's House,  
58 French Street, Southampton SO14 2AT**

**Graffiti Survey summary**

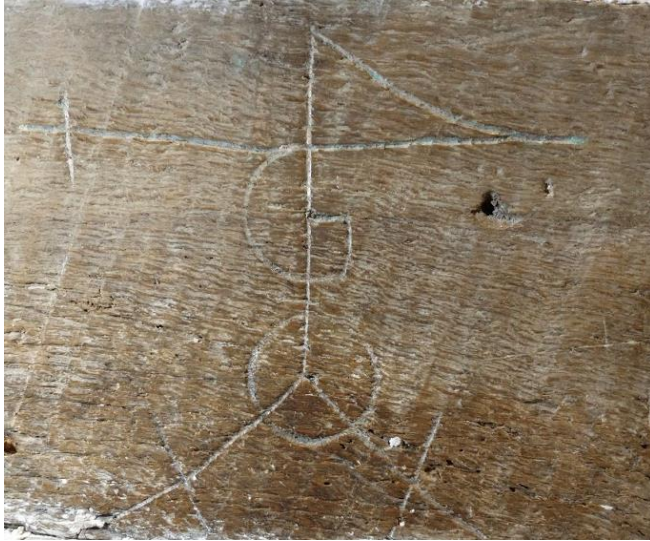
Tudor House, where there is one on the ground floor back corridor, incised into the timber frame near the side door (Fig 10), and there are more upstairs, incised into the plaster walls of the rooms overlooking St Michael's Square. There are also some on the inner arch of the Bargate. (Fig 11).

*Fig 10 Tudor House, Southampton. Ground floor corridor, merchant mark*

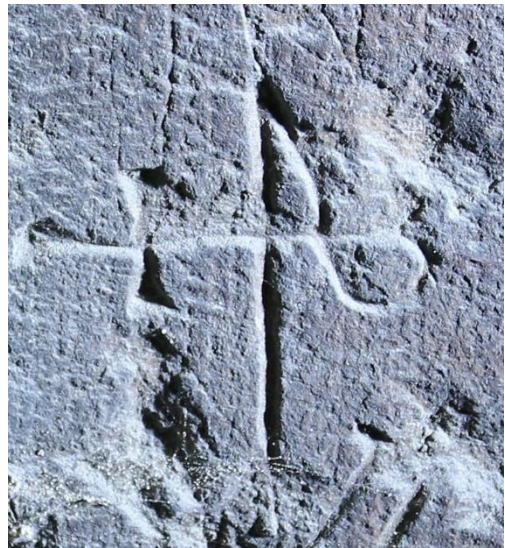
*Fig 11 Southampton Bargate, inner arch. Merchant mark*

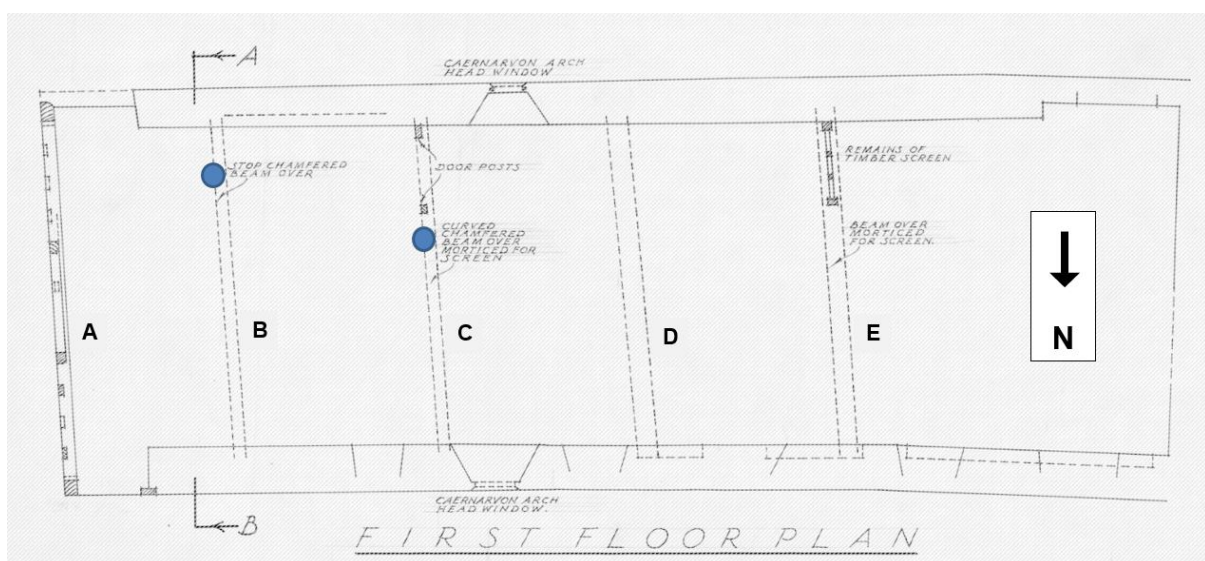
The mark on the east face of the Truss B tie beam (Figs 12, 13) is 2.07m from the north wall. It is above head height, so, assuming floor levels are unchanged, it is in an awkward location to leave a mark. It has the standard vertical upright, with a double looped shape on the RHS and a central circle above this. At the top is the reversed 4 shape which, as well as a normal 4 shape, is found on the majority of merchant marks. It has the characteristic inverted V base, made of curved lines, but one arm extends and has 2 arcs incised across it. If this is part of the original mark it is a very unusual feature. Examples are known of marks being modified when passed on, eg by father to son, so this could be an explanation. Equally, it may be another piece of overlapping graffiti. Merchant marks often incorporated the owner's initials so the double loop could be intended as an initial B, although a study of

Plan 1. Location of merchant marks on tie beams of Trusses B and C

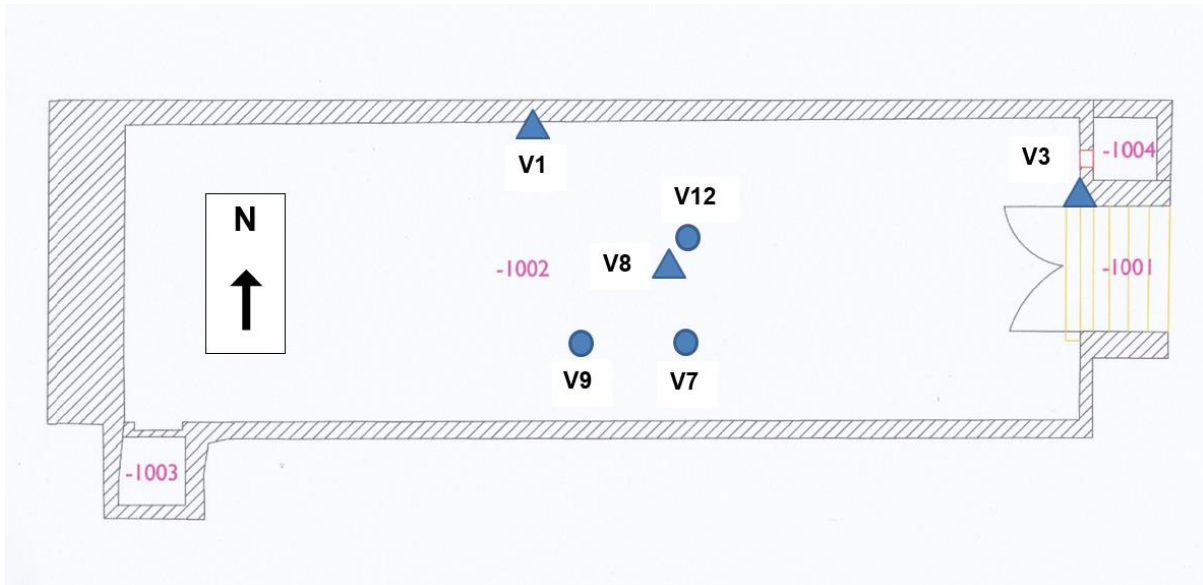
The surface of many of the ashlar blocks forming the vault were obscured with dirt and layers of limewash, but graffiti was found on one block, consisting of incised lines forming cross shapes. A sketch was made of this (Fig 18). Its location, as V1, is shown on Plan 2.

Markings relating to the construction of the vault were found on several blocks. These consist of groups of incised vertical lines, the number of lines indicating the thickness of the stone. These marks were made by masons, presumably off site, to aid with the construction of the vault. (Fig 19). The location of these marks is shown on Plan 2, as V7.

Plan 2. Vault. Location of graffiti V1 and masons' marks V7
