St John the Baptist, North Baddesley

Graffiti Survey Summary

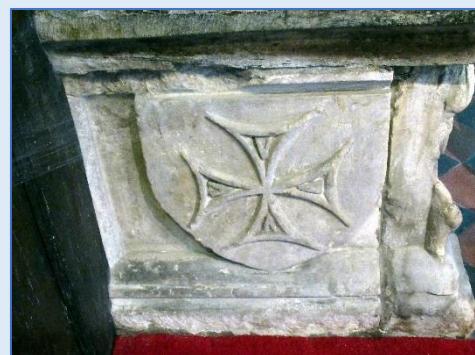
Figure 3 Hospitallers cross on tomb

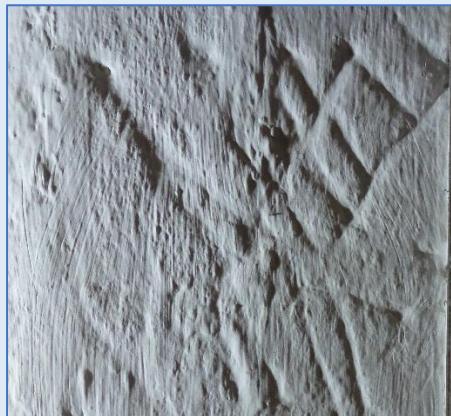
outline beneath, filled with a mesh pattern. The hand is well known to the church and was the source of inspiration for the design of a modern stained glass window opposite in the north wall. There are also names, initials and dates (some relatively recent), crosses, and some possible ritual protection or apotropaic marks in the form of double Vs and a “butterfly” shape.

Figure 5 Double V by S doorway

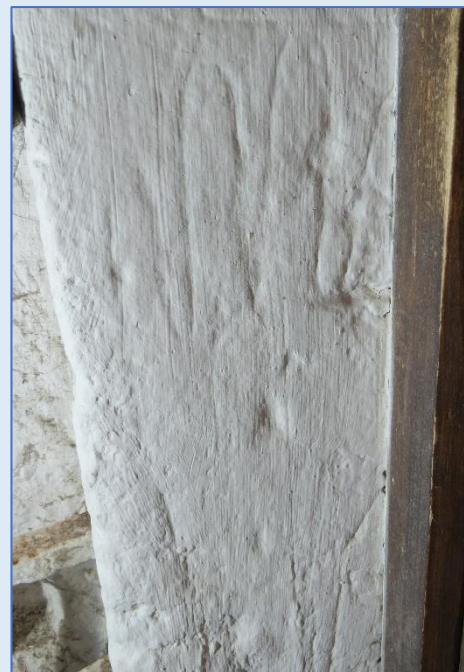
Some interesting graffiti was found here, mostly around the south doorway. Striking is a large hand outline on the east side of this doorway, with another possible hand

Figure 4 Hand outline on S doorway

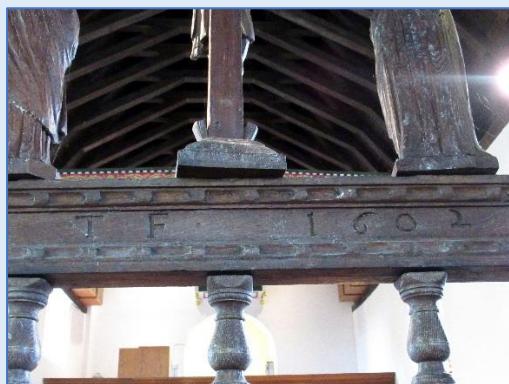
The wooden screen bears the initials TF and date 1602 and is thought to come from North Stoneham church, thus linking the initials to Thomas Fleming. The pulpit seems contemporary and bears the well carved initials I M.

Figure 6 The screen with initials TF and 1602

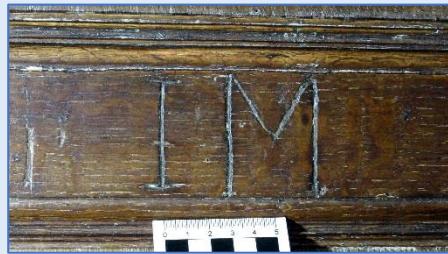
Figure 7 Initials IM on pulpit

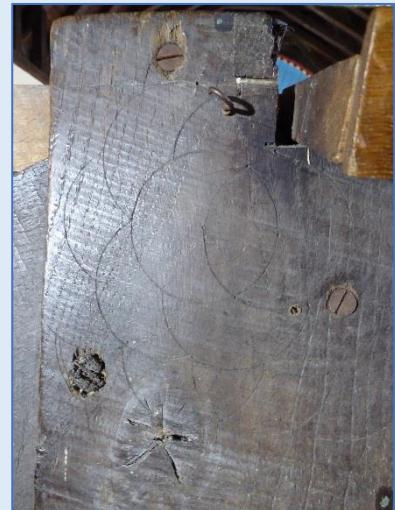
The gallery was apparently built in 1822 but contains earlier timbers. The top of the vertical timber supporting the gallery front has an impressive group of 23 overlapping compass-drawn circles at the top, which could be apotropaic in function.

Figure 8 Intersecting circles in gallery

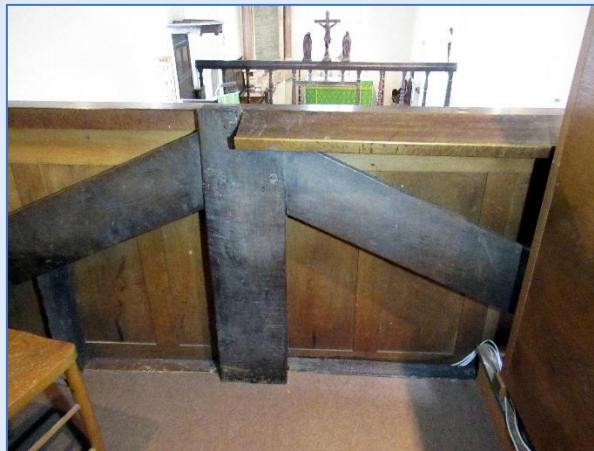
Along the top of the diagonal frontal support joining it on the southern side are a number of incised letters, including many Ms and Ws, which may well be protective also.

Figure 9 Re-used timbers bearing graffiti at front of gallery
